Introduction

Single posteriors

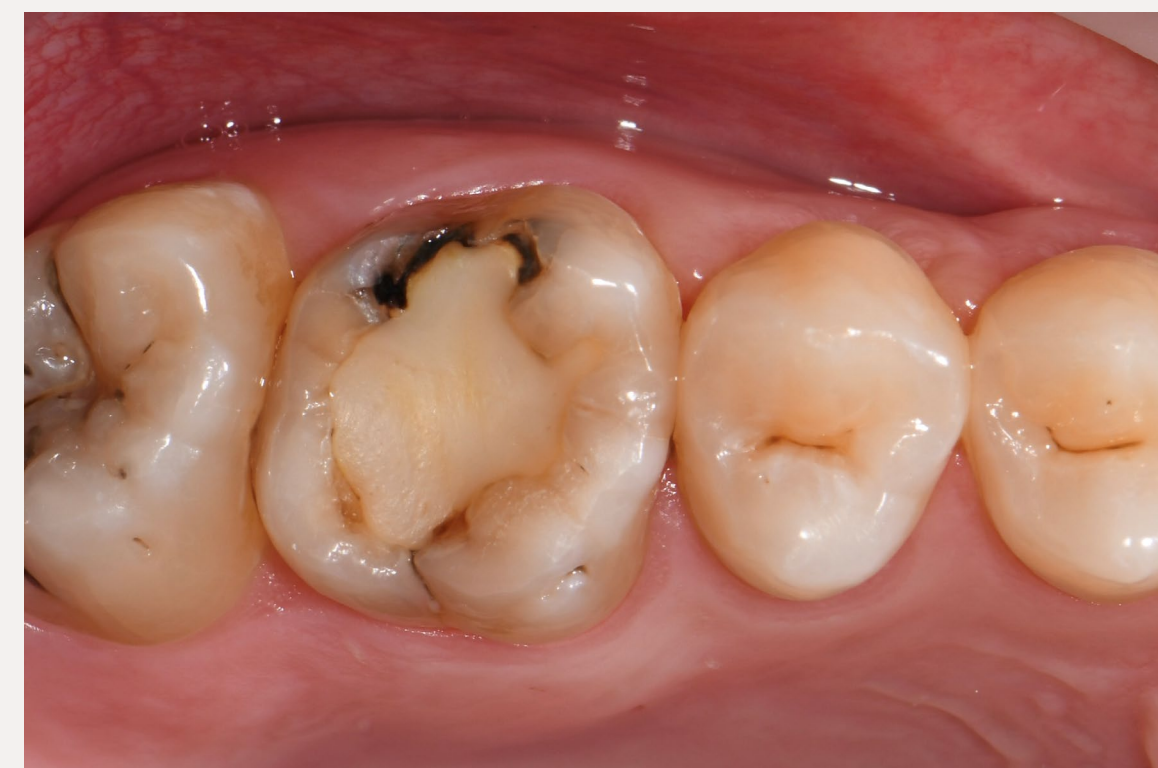
Before:
First upper molar had been restored with an extensive yet insufficient composite filling that already showed visible fractures.

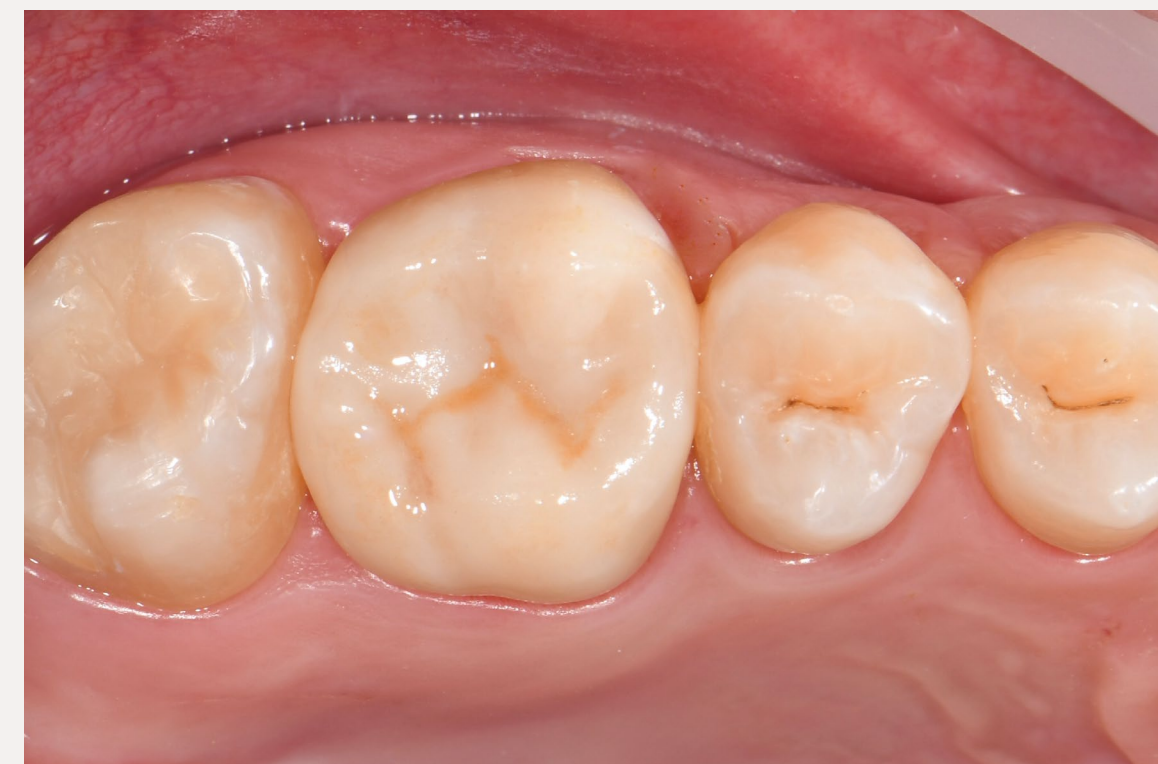
After:
Chairside-fabricated restoration made from an advanced lithium disilicate ceramic, CEREC Tessera.

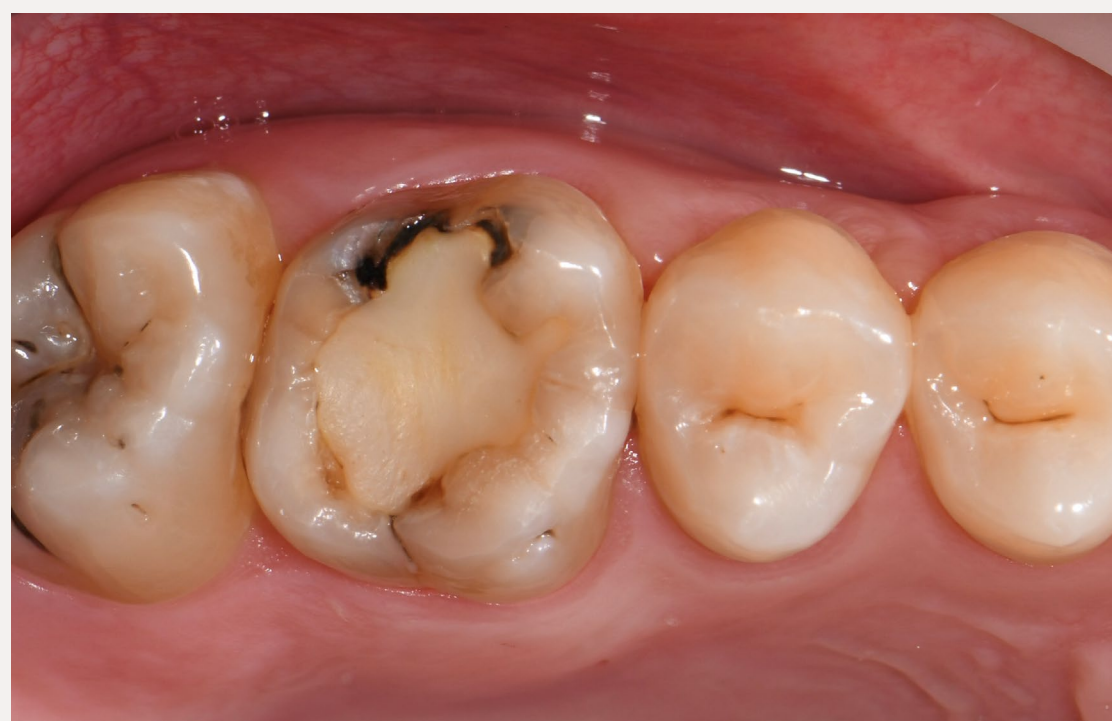
Pre-op with decay and composite filling breaking down.

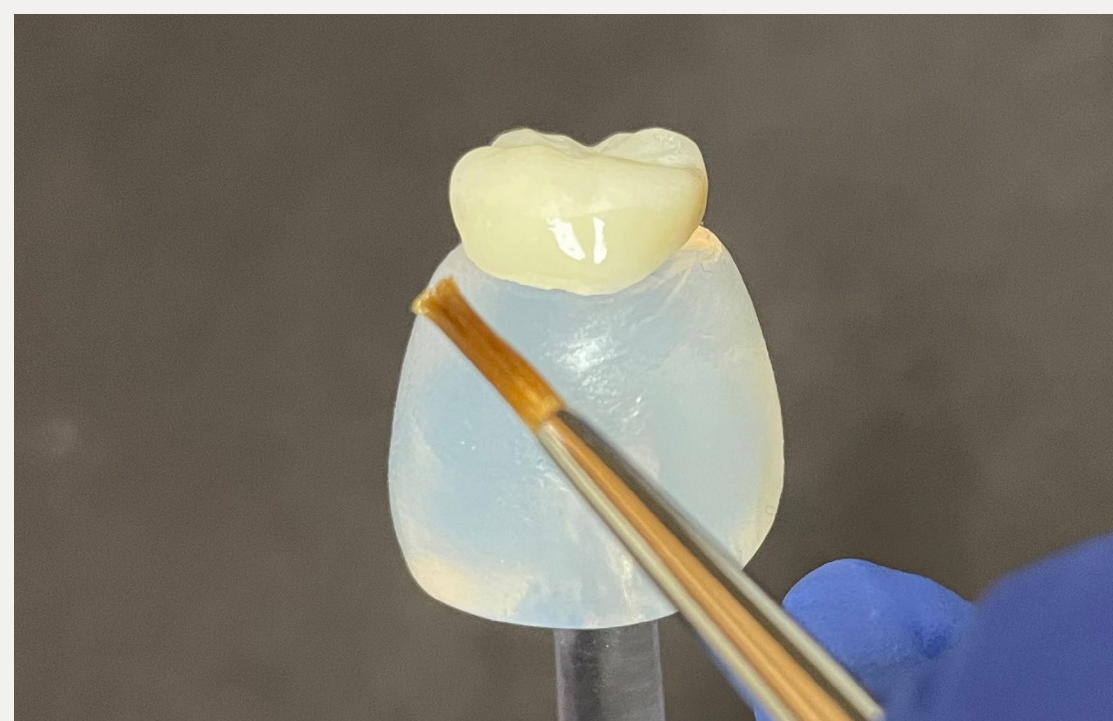
For the glaze and optional stain step, the crown is placed on a moldable silicone. Buccal stain is added with a brush. A mixture of two shades – Olive and Sunset (Universal Stains by Dentsply Sirona) – was used.

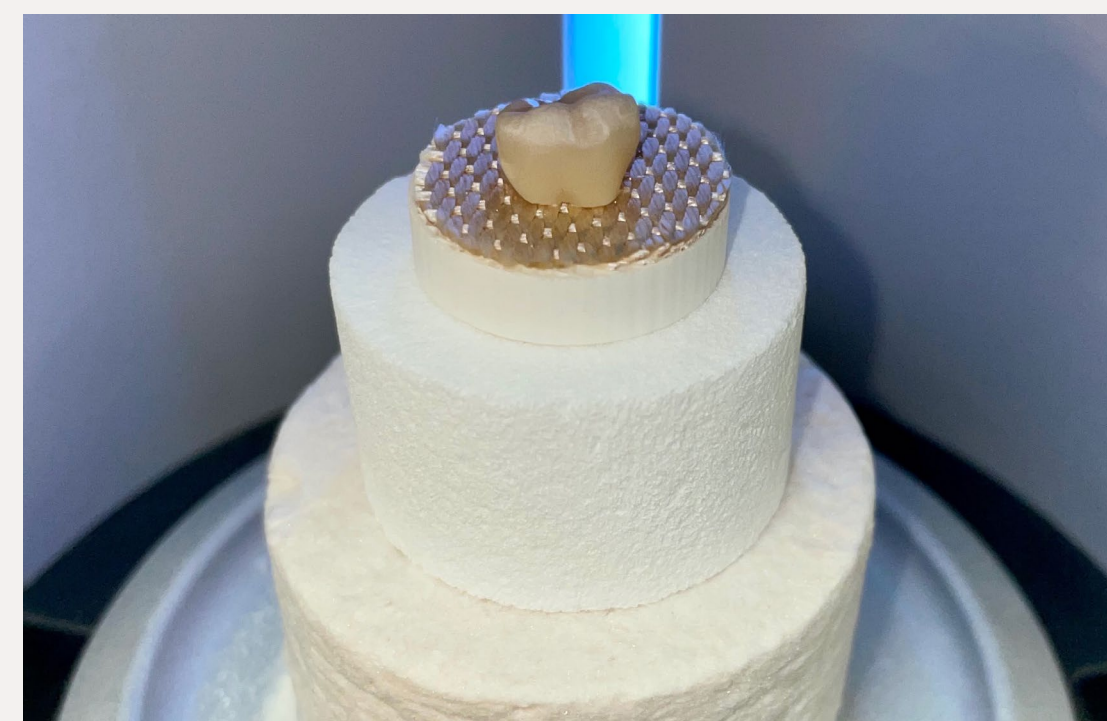
The crown is placed on top of the CEREC SpeedFire honeycomb tray with a firing pad. It must be centered on the pad. The construction is then placed in CEREC SpeedFire.

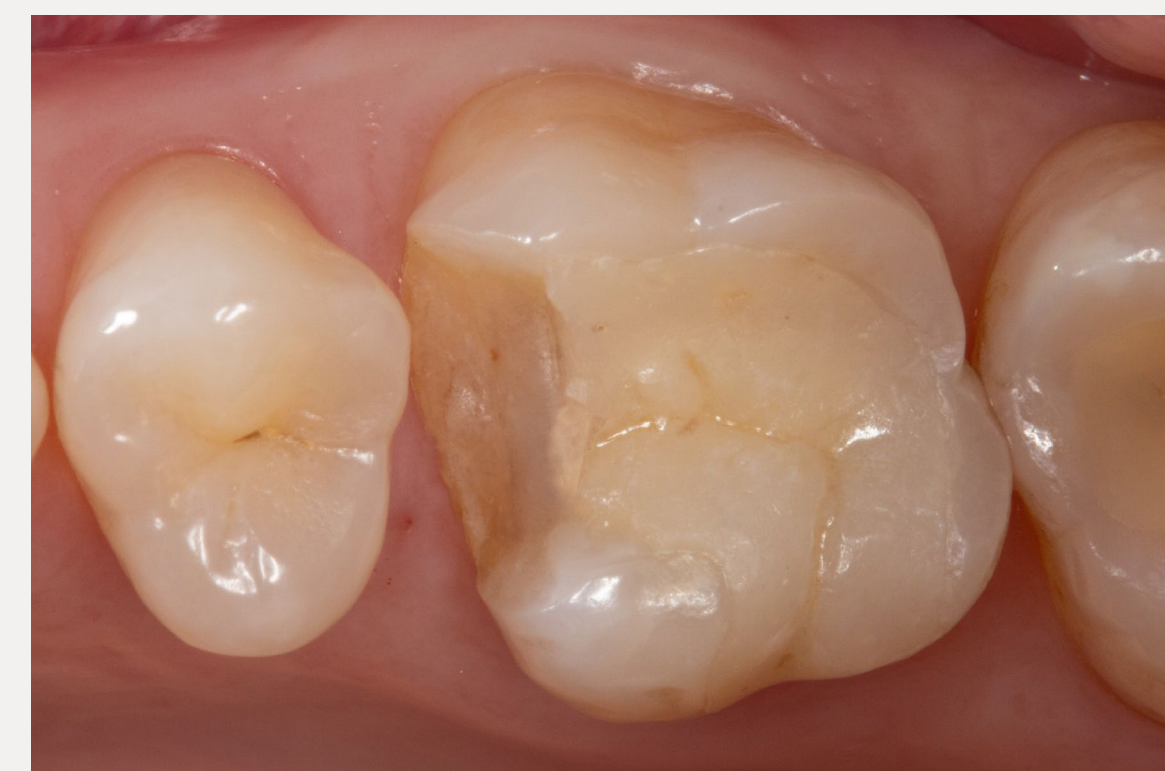
Before:
Fractured ceramic restoration made from a leucite-reinforced glass-ceramic after a clinical service time of 12 years.

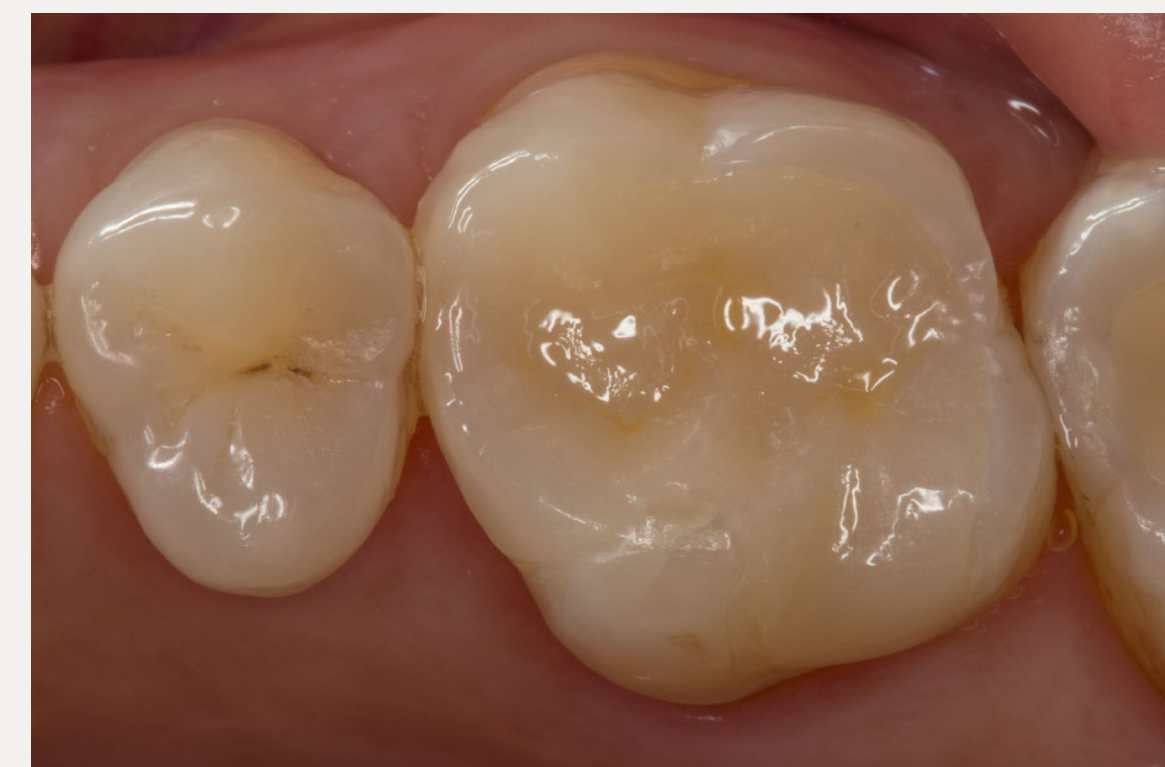
After:
Chairside-fabricated restoration made from an advanced lithium disilicate ceramic, CEREC Tessera.

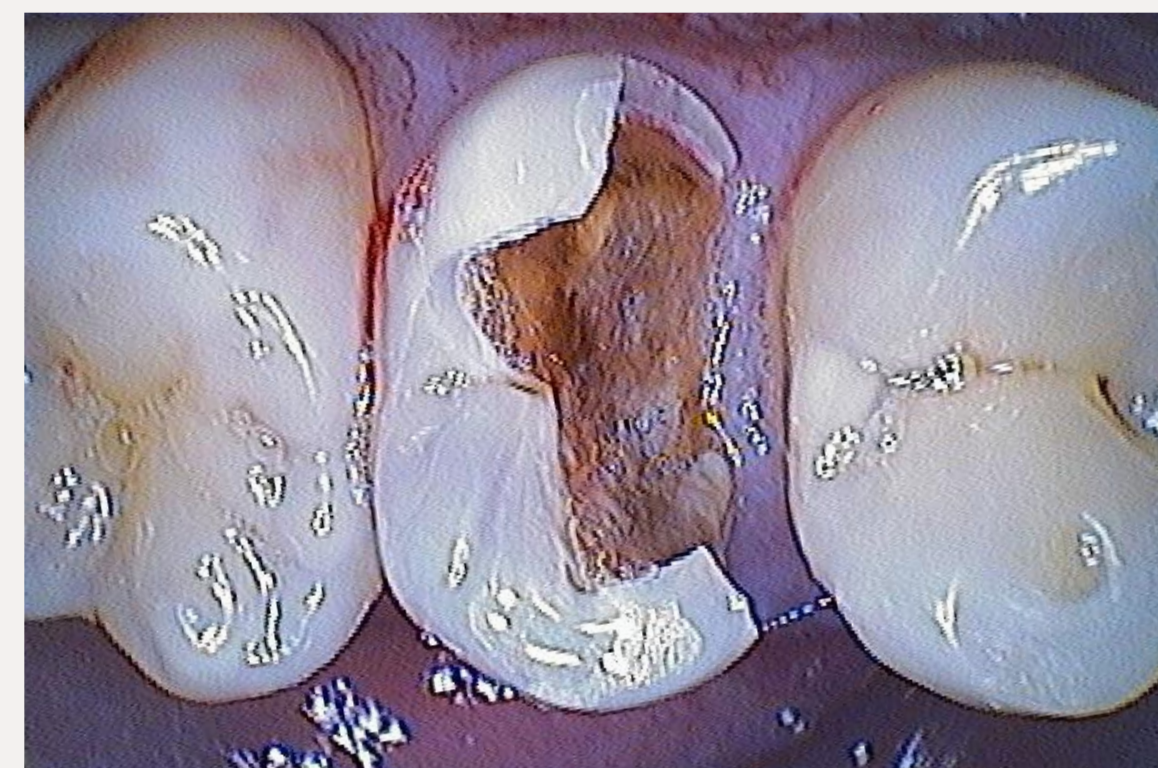
Before:
A large carious mesial lesion on tooth 15. The tooth showed asymptomatic apical periodontitis and a significant loss of tooth structure.

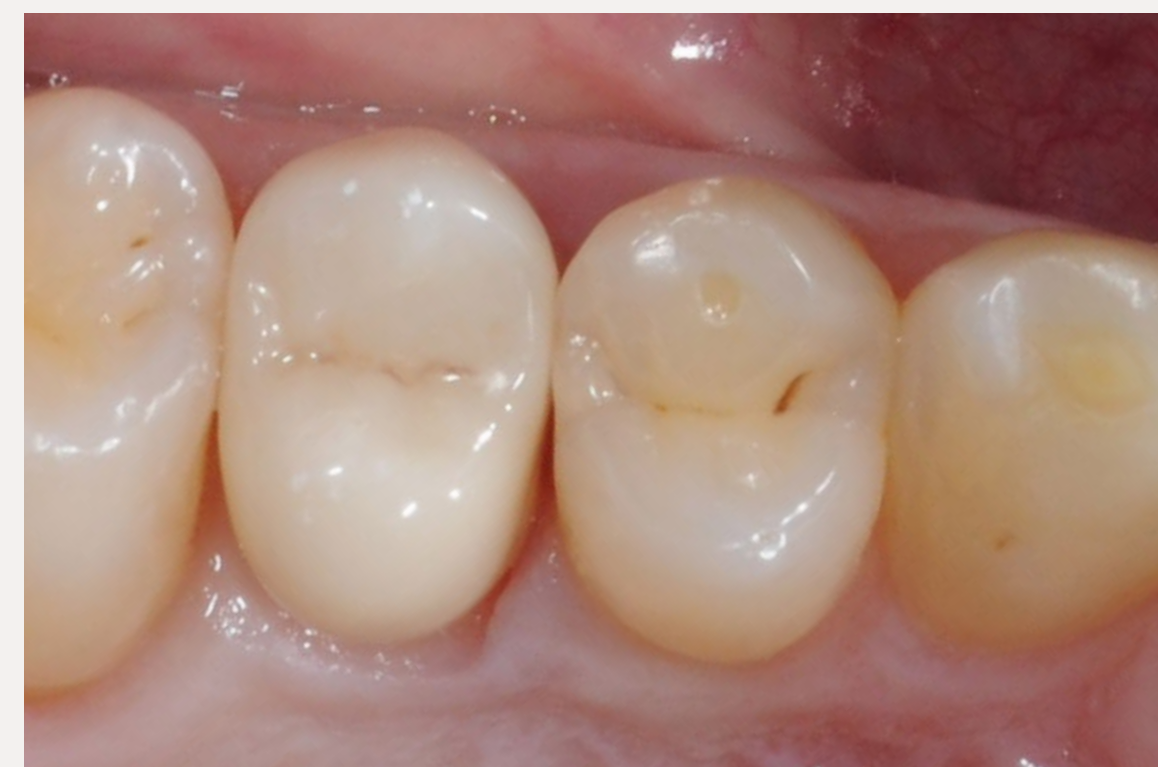
After:
Chairside-fabricated restoration designed using the Biogeneric individual function. CEREC MTL Zirconia was the material selected because it promises both high strength and exceptionally good esthetics.

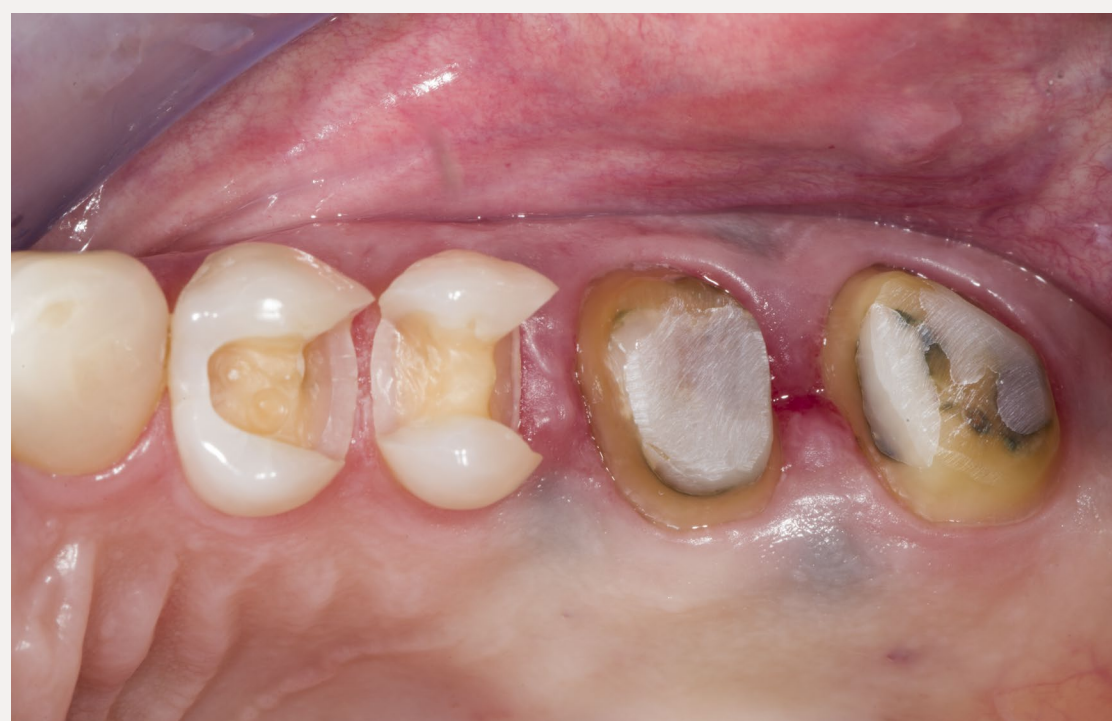
Patient with insufficient fillings in the second quadrant and inadequate esthetics of the PFM crowns on teeth 26 and 27. The composite filling on tooth 25 showed an open discolored joint with incipient secondary caries, and a distinct step was palpable toward the cervix of tooth 24 on the filling.

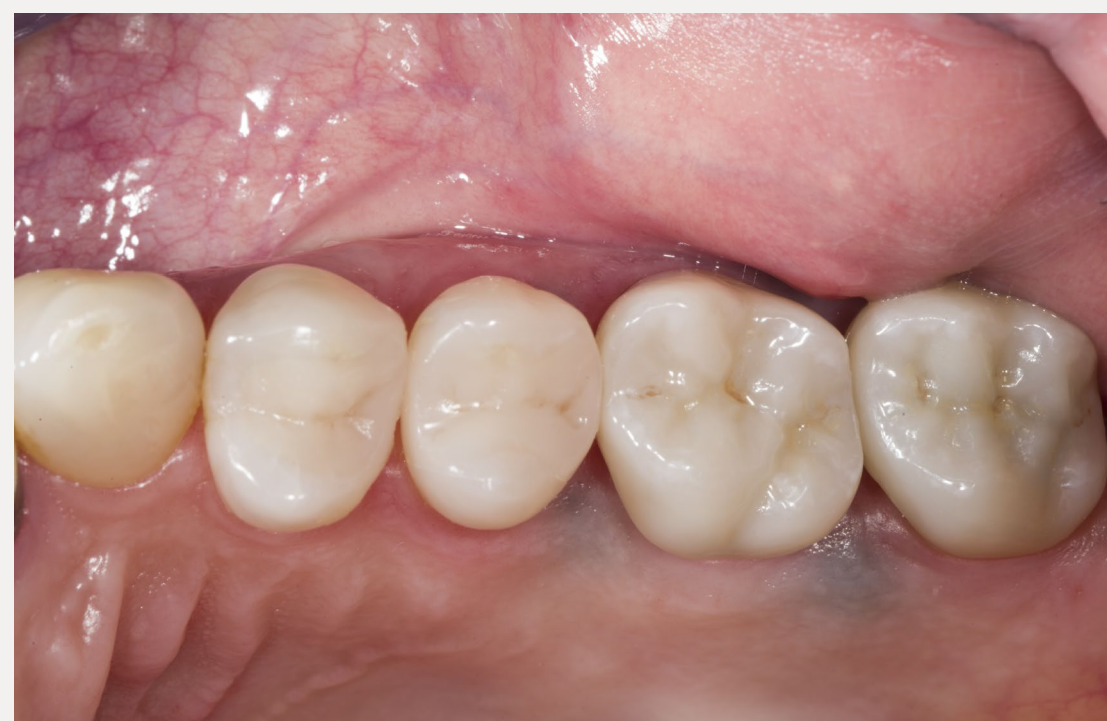
Final crown and inlays – occlusal.

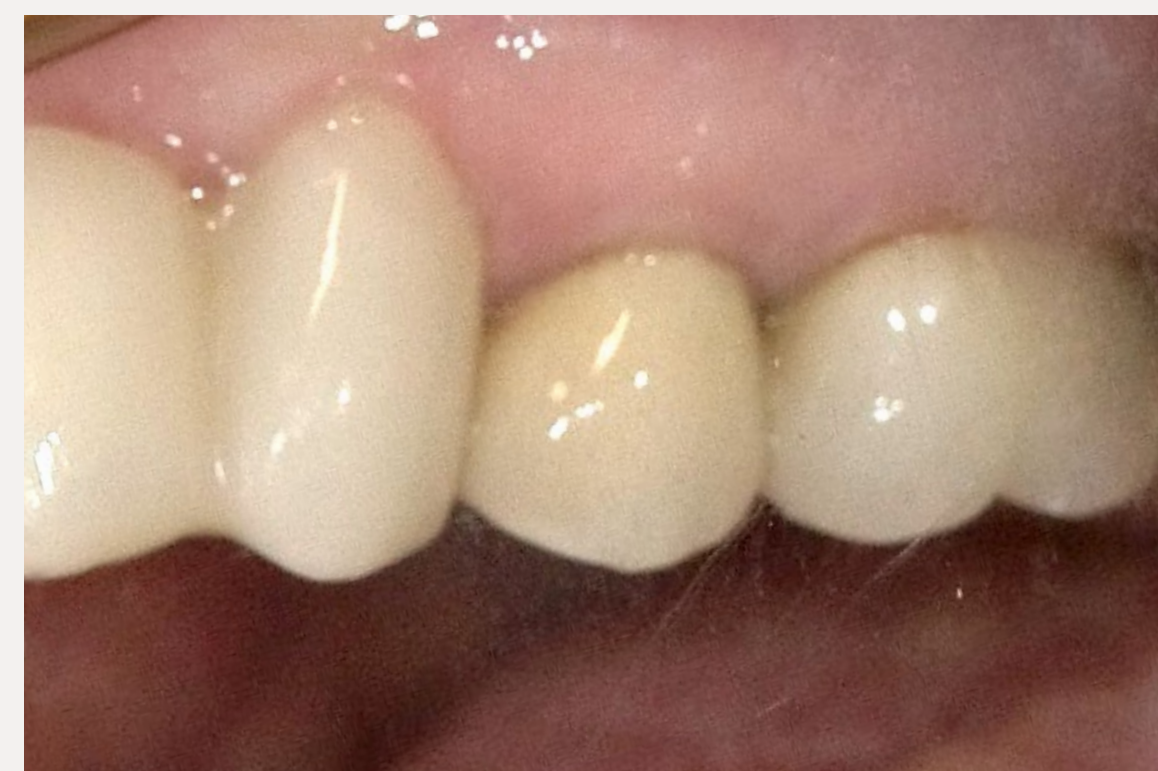
Before:
Tooth 25 had mesial and distal marginal decay and broken porcelain on the existing PFM.

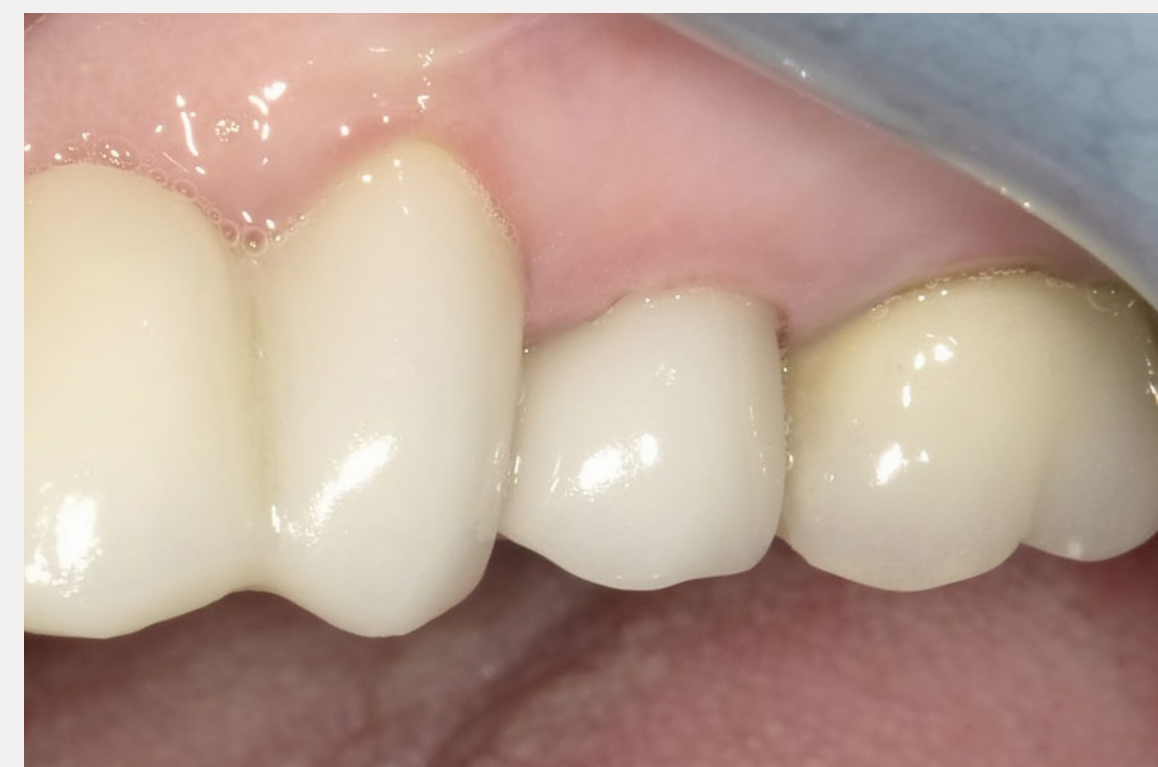
After:
The crown on tooth 25 was remade to be brought more in line facially and incisally with the arch.

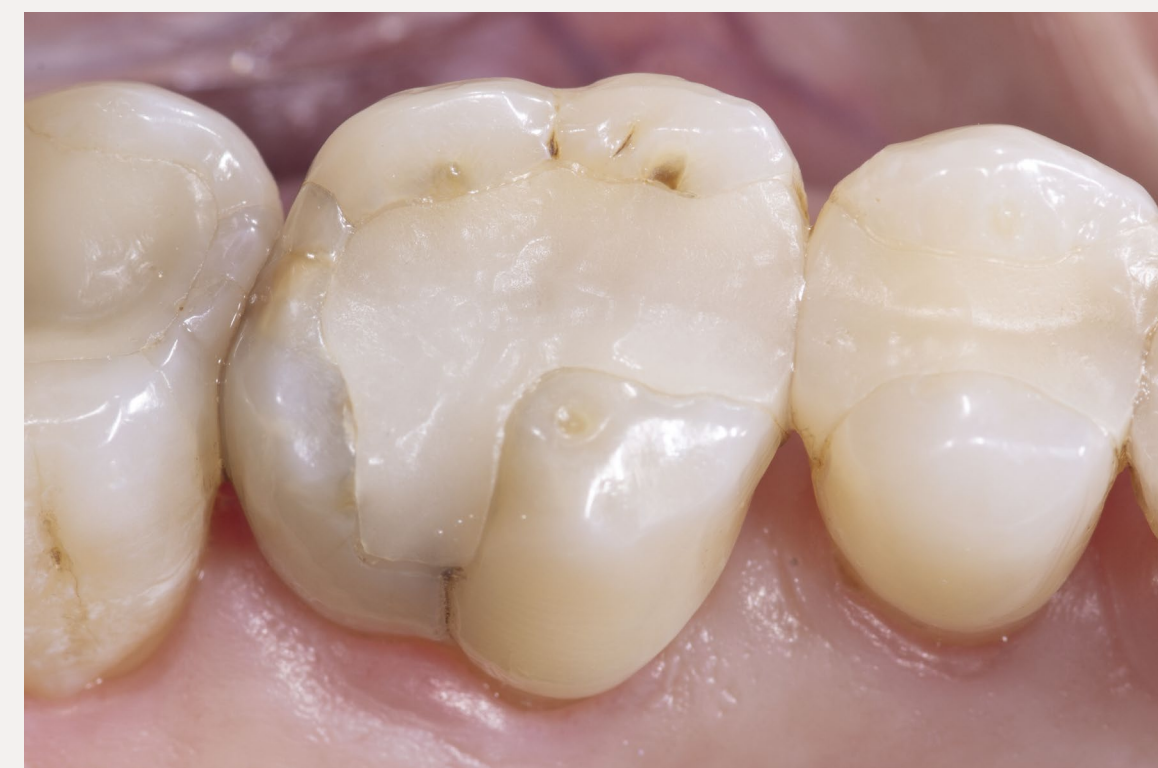
Before:
Large insufficiency of the composite filling on tooth 16 with distal marginal ridge cracks, a lingual wall crack, and distal recurrent decay.

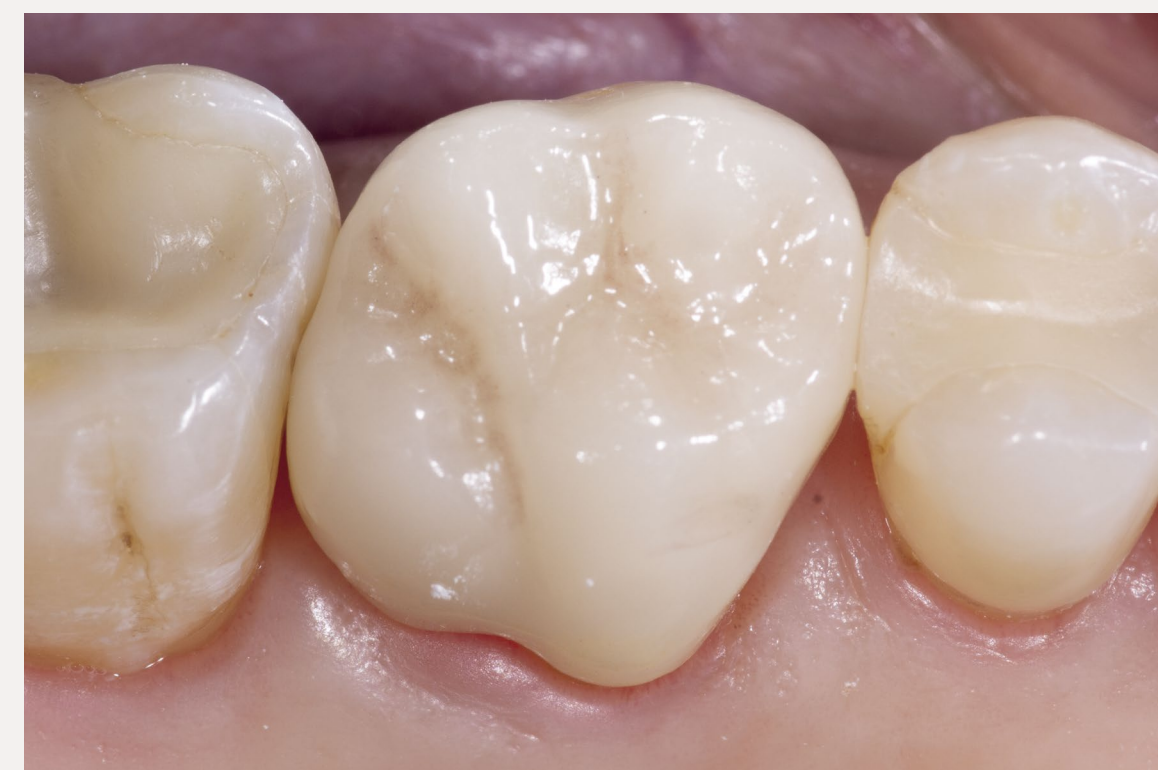
After:
Highly esthetic full-surface glass-ceramic crown.

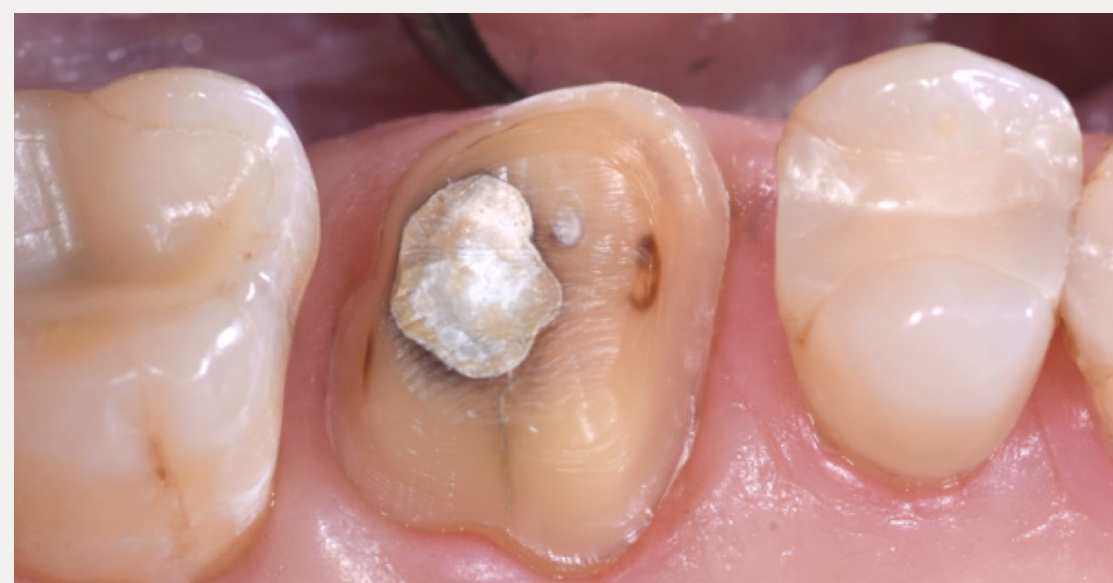
The previous failing restoration was removed, and both mesial and distal recurrent decay was found and excavated. No pulp was exposed upon completed excavation. A composite core buildup was completed using a glass ionomer liner (3M Vitrebond) and composite resin (Empress Opaque, Ivoclar Vivadent).

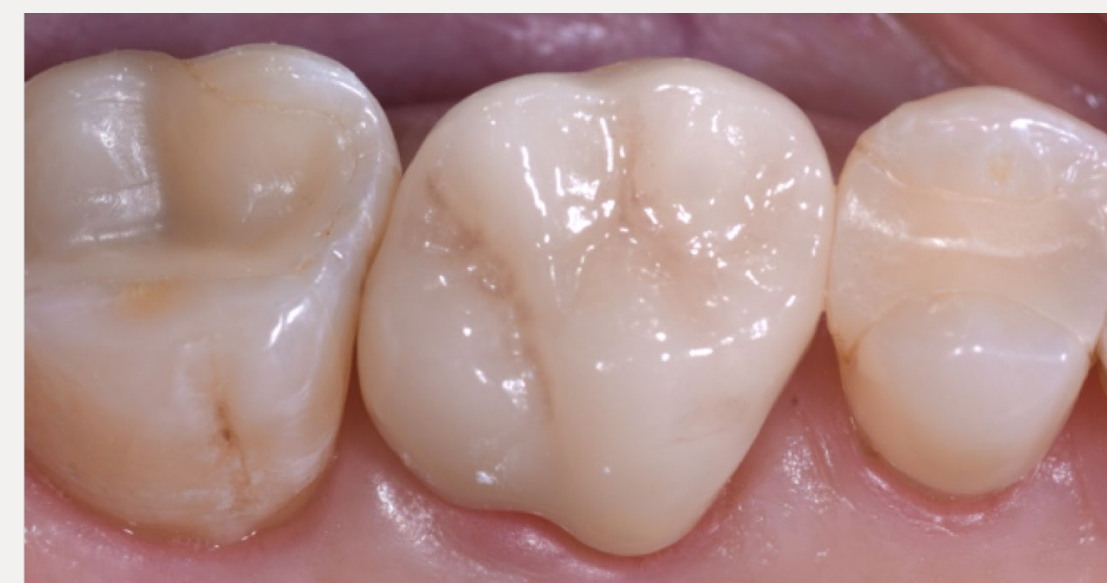
After crystallizing and stream cleaning the restoration, the e.max CAD was prepared for bonding and bonded with resin cement.

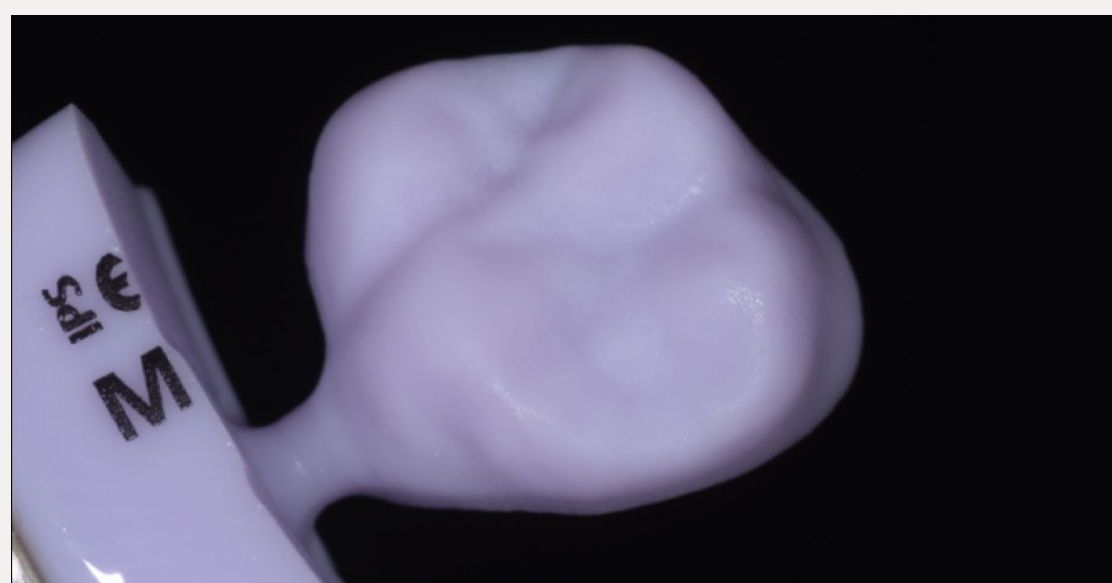
The local parameter marginal thickness was adjusted to 100 µm. The design phase was then completed with very little modification to the fissure height and contours. The design was evaluated for proper occlusion, contacts and contours.

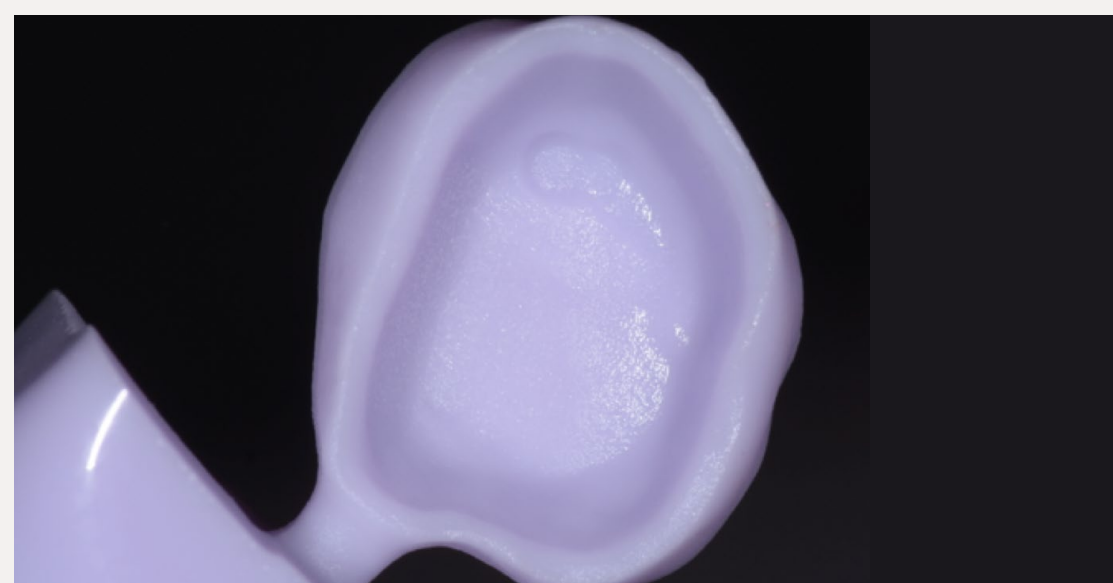
Since the touch process had been completed in advance, the grinding began right away after the restoration was sent to the CEREC Primemill. The e.max restoration was grinded in 3:54 without any marginal chipping. The fit was checked, and no further adjustments were needed.

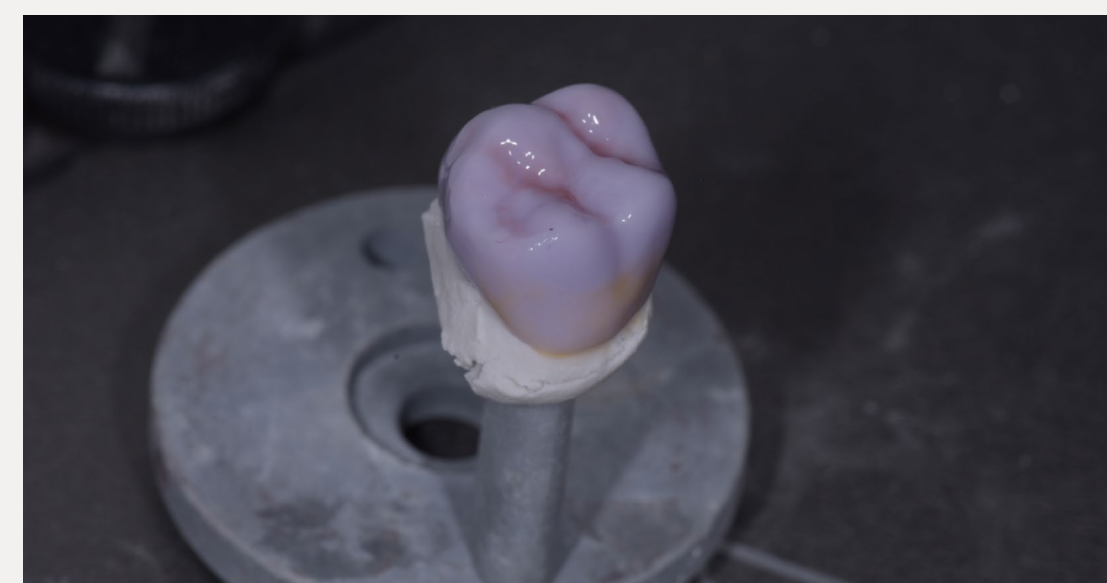
The restoration was then glazed and stained using Ivoclar Vivadent IPS e.max CAD Crystall Shades, Stains and Glaze Paste.

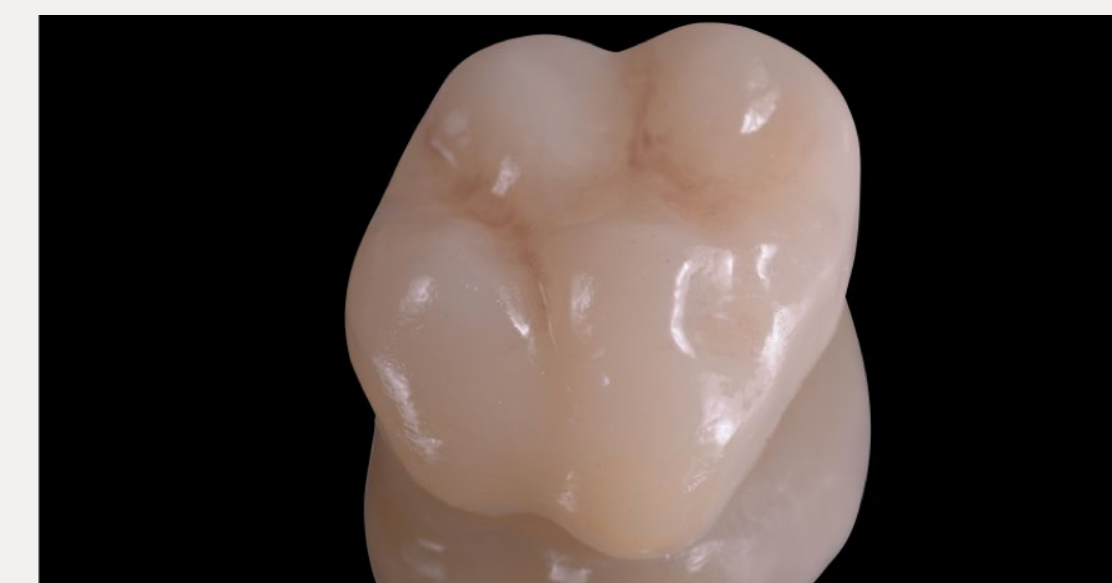
It was then crystallized in a furnace.

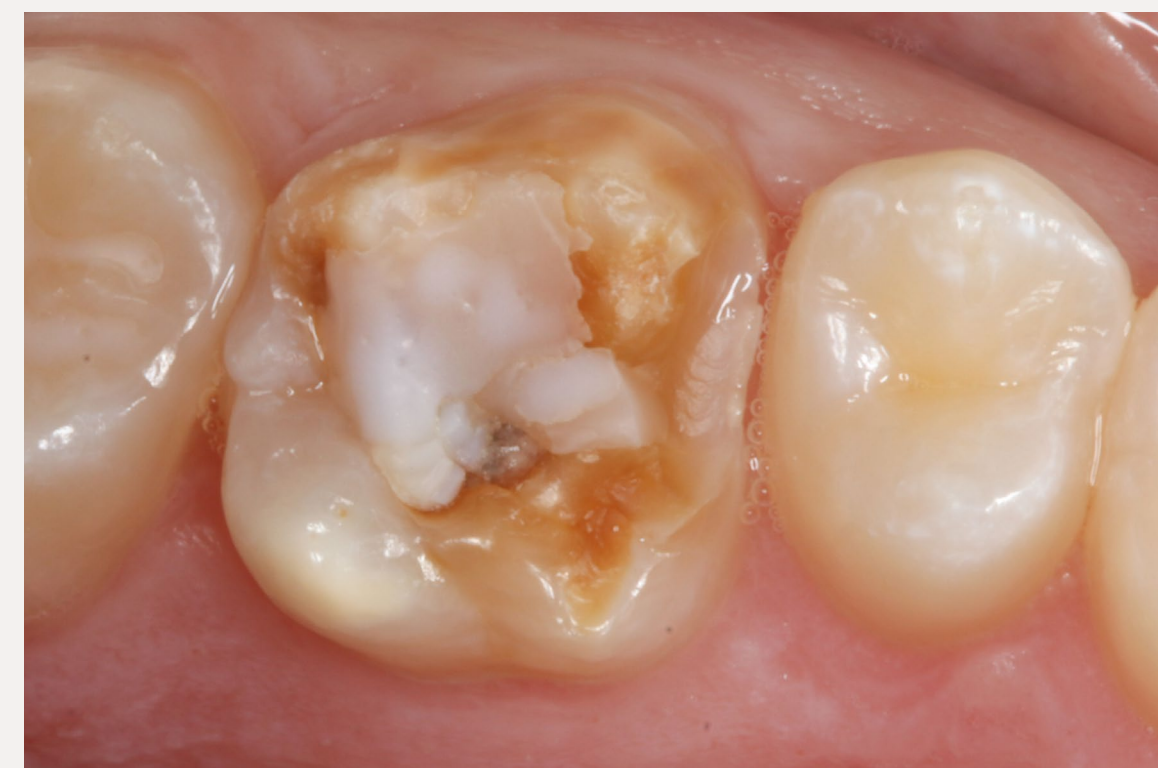
Before:
Tooth 26 presenting decay and a failing direct composite restoration.

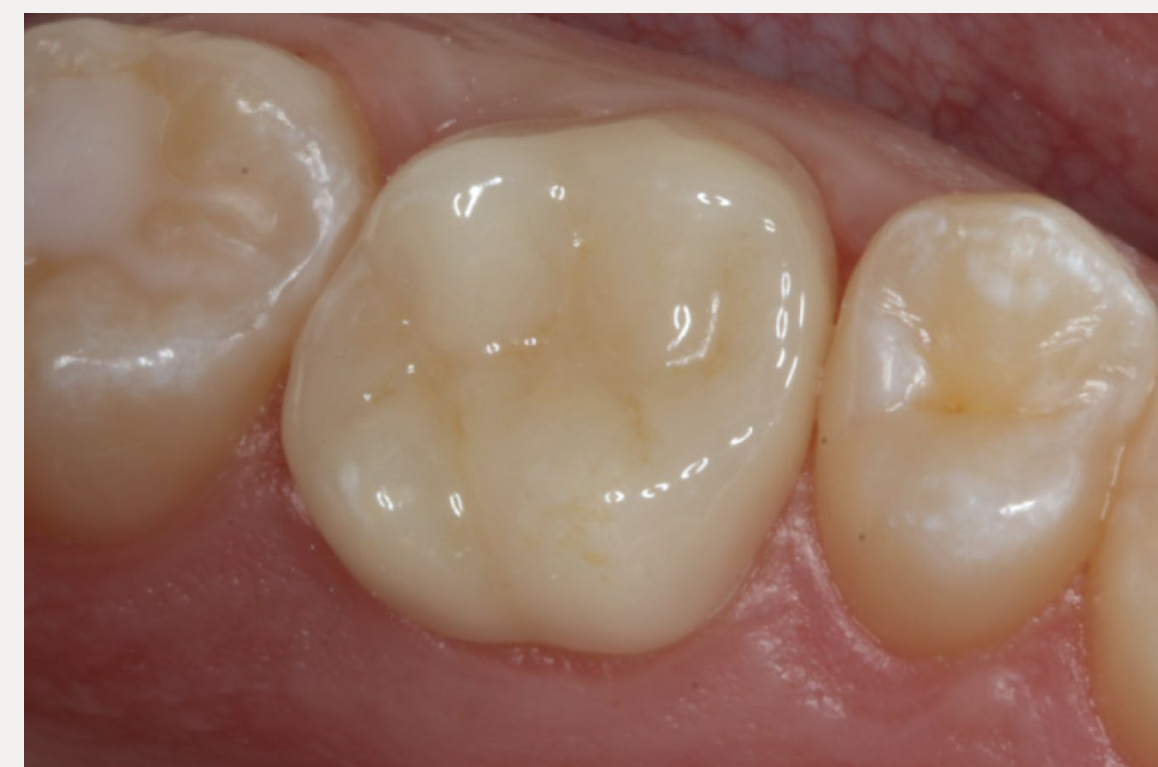
After:
Highly esthetic and functional lithium disilicate ceramic crown.

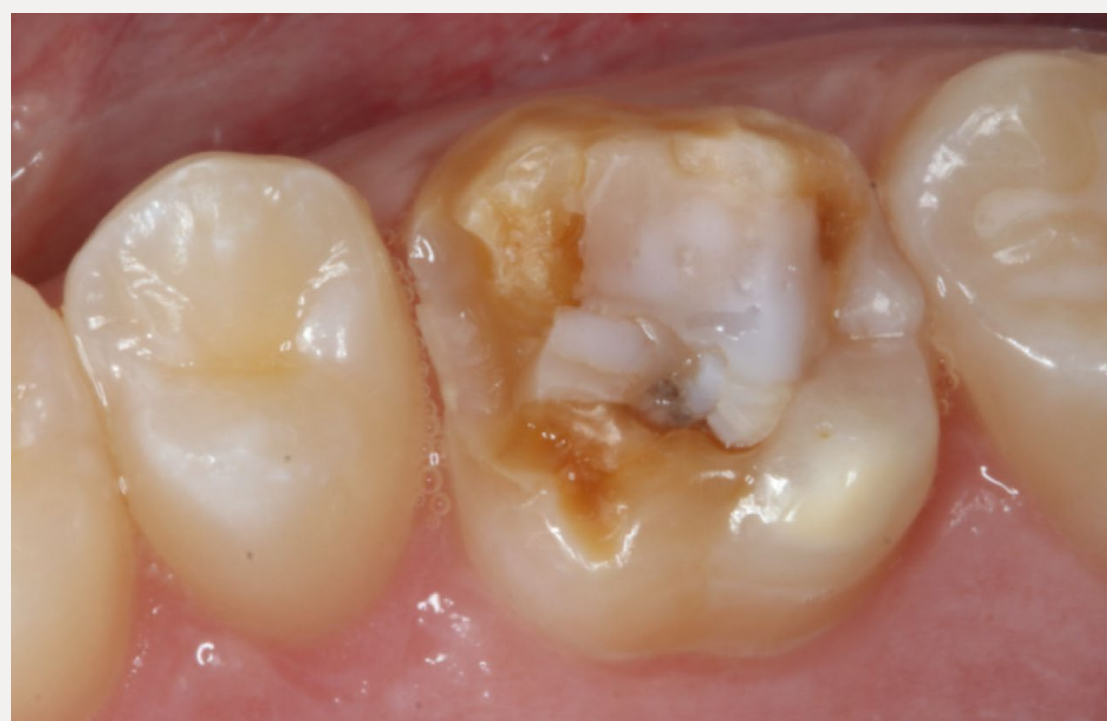
Pre-op tooth 26 with a failing composite restoration and recurrent decay.

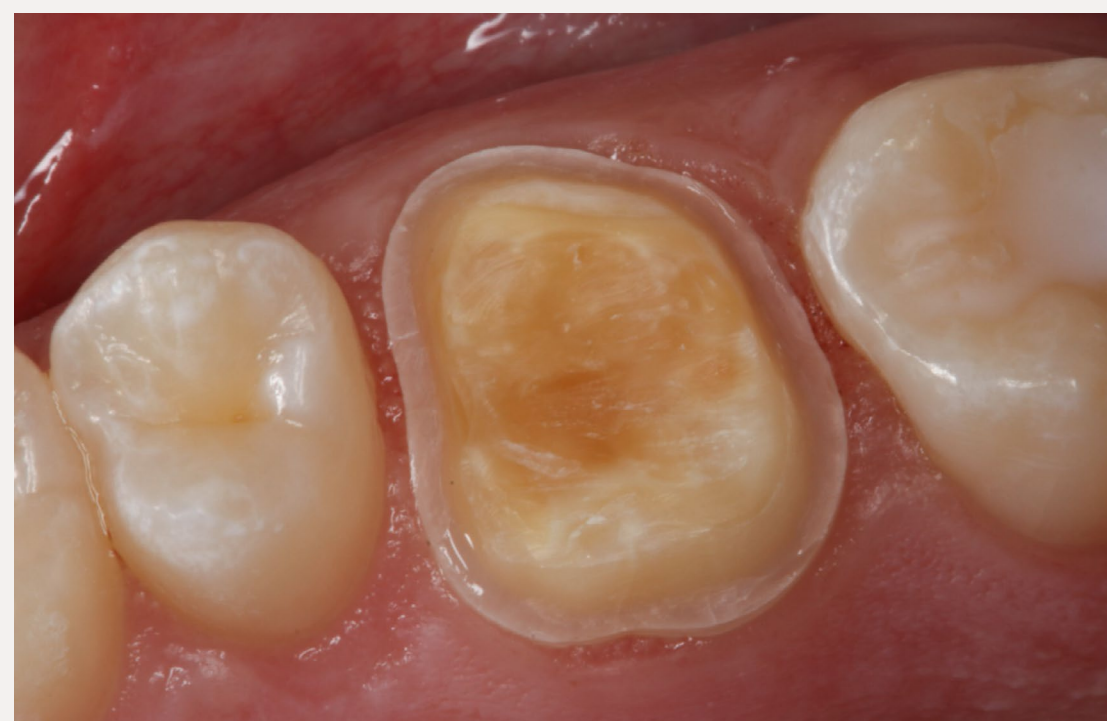
The old restorative material and the decay were removed, and the tooth has been prepared for a full-coverage crown.

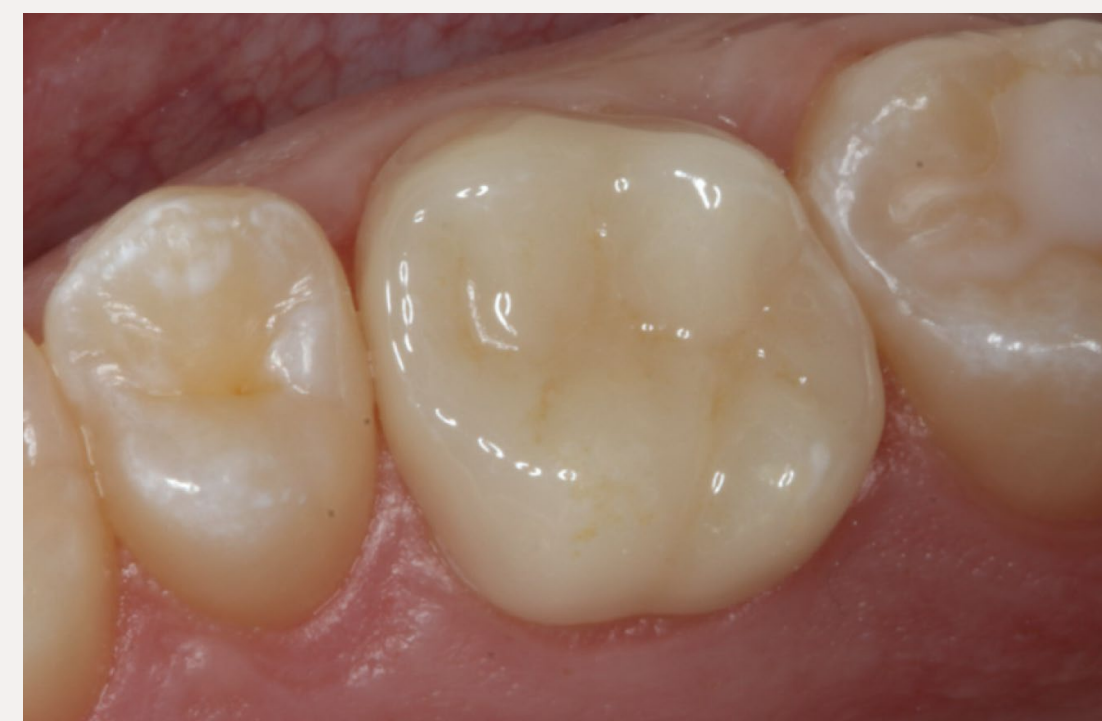
The final e.max crown bonded in place.

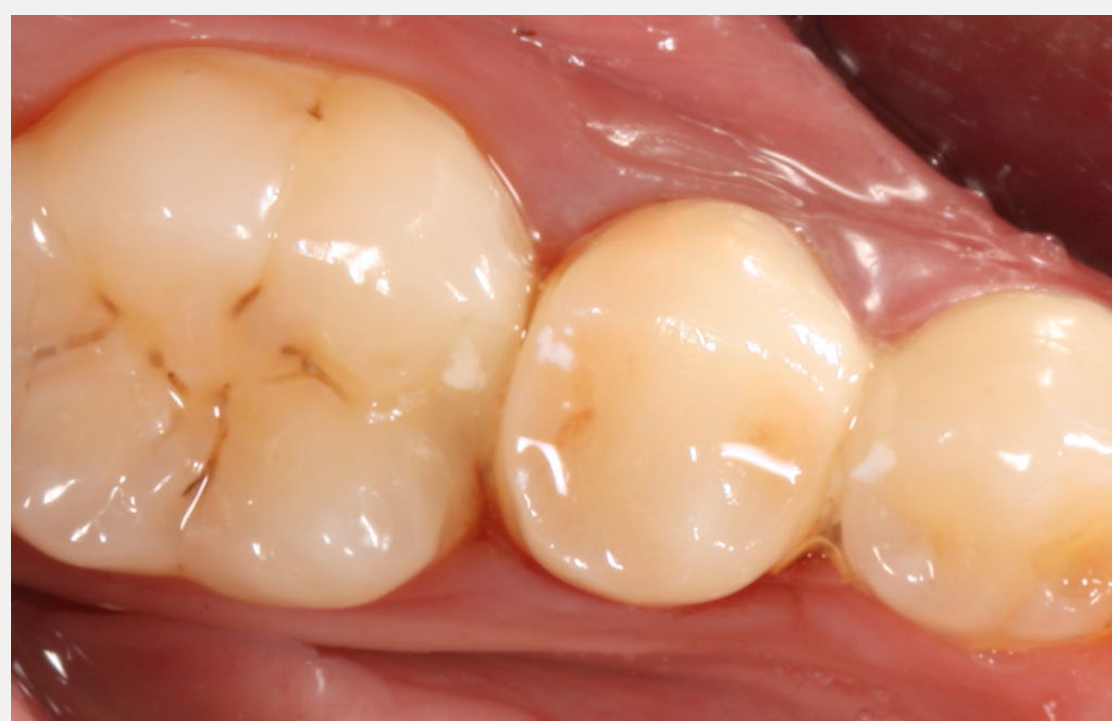
Postprocessing: stain and glaze by my dental assistant.
