Introduction

Single posteriors

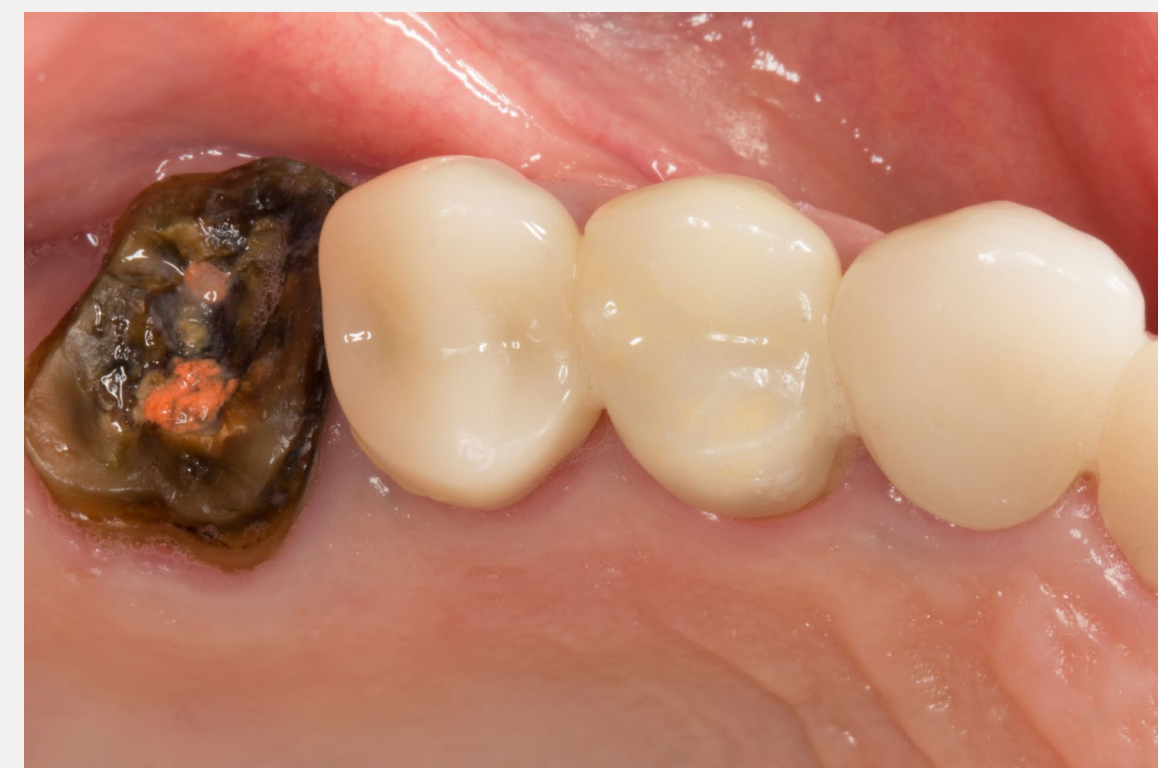
Before:
Fractured metal-ceramic crown on tooth 26, which had previously been treated endodontically.

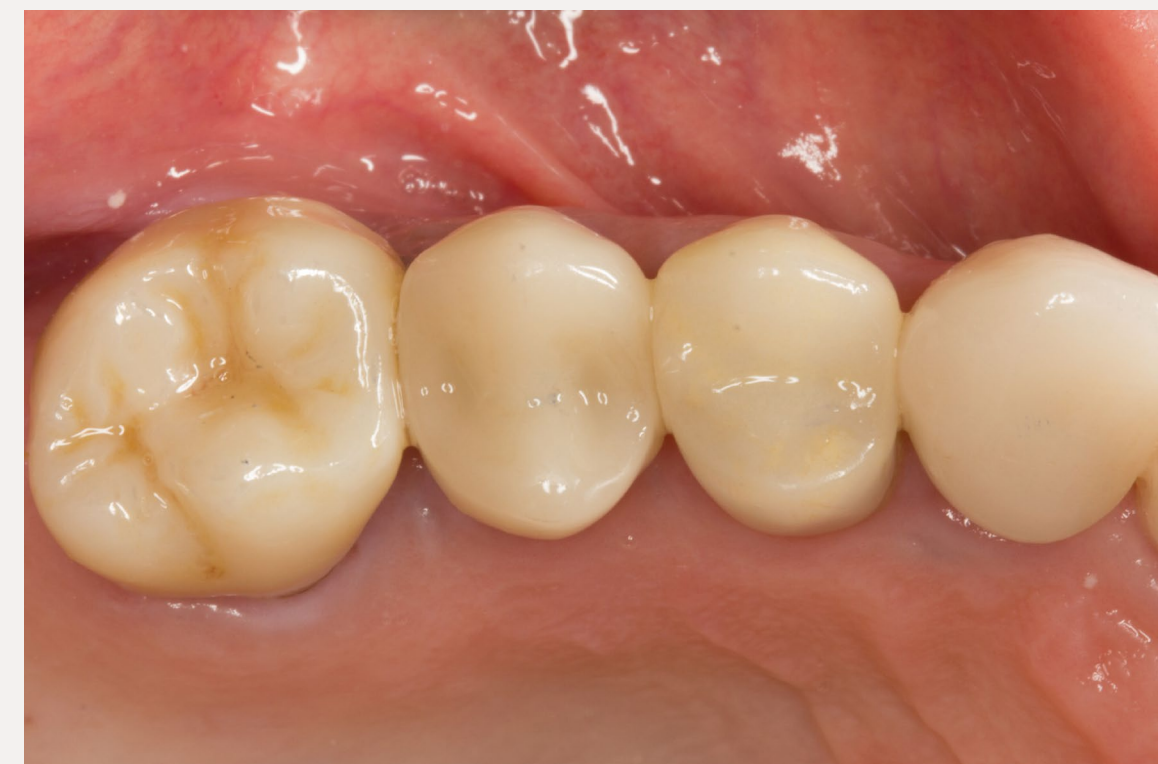
After:
Translucent full-zirconia crown for an esthetic result with maximum resistance and retention shape.

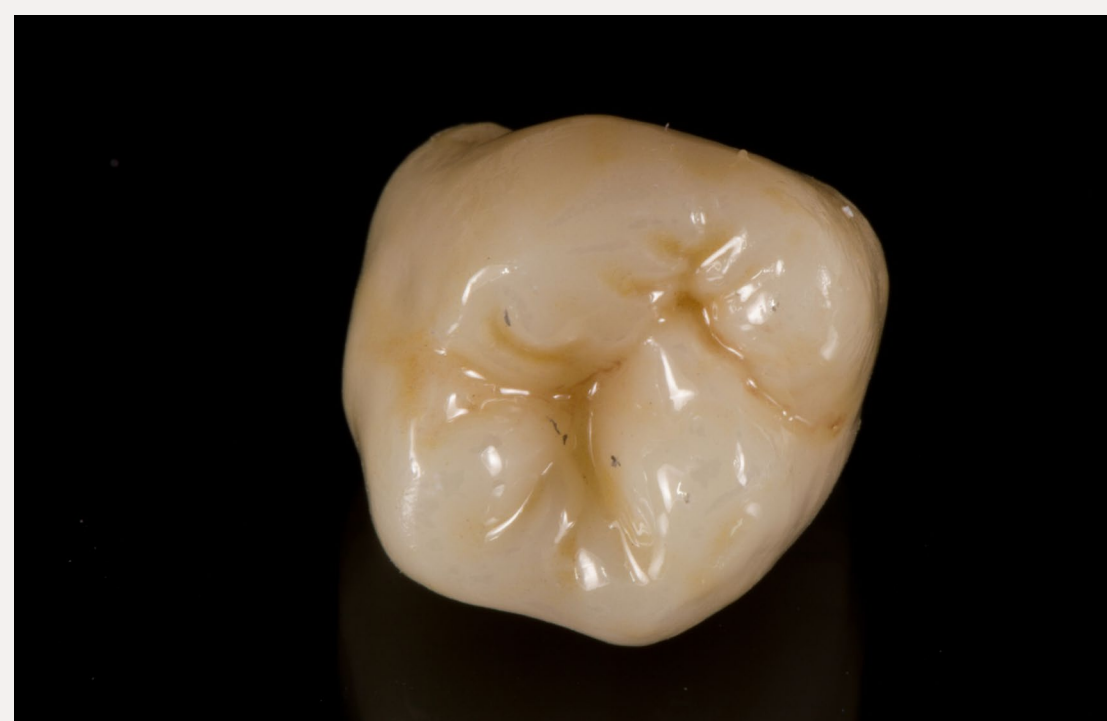
Final stain and glaze.

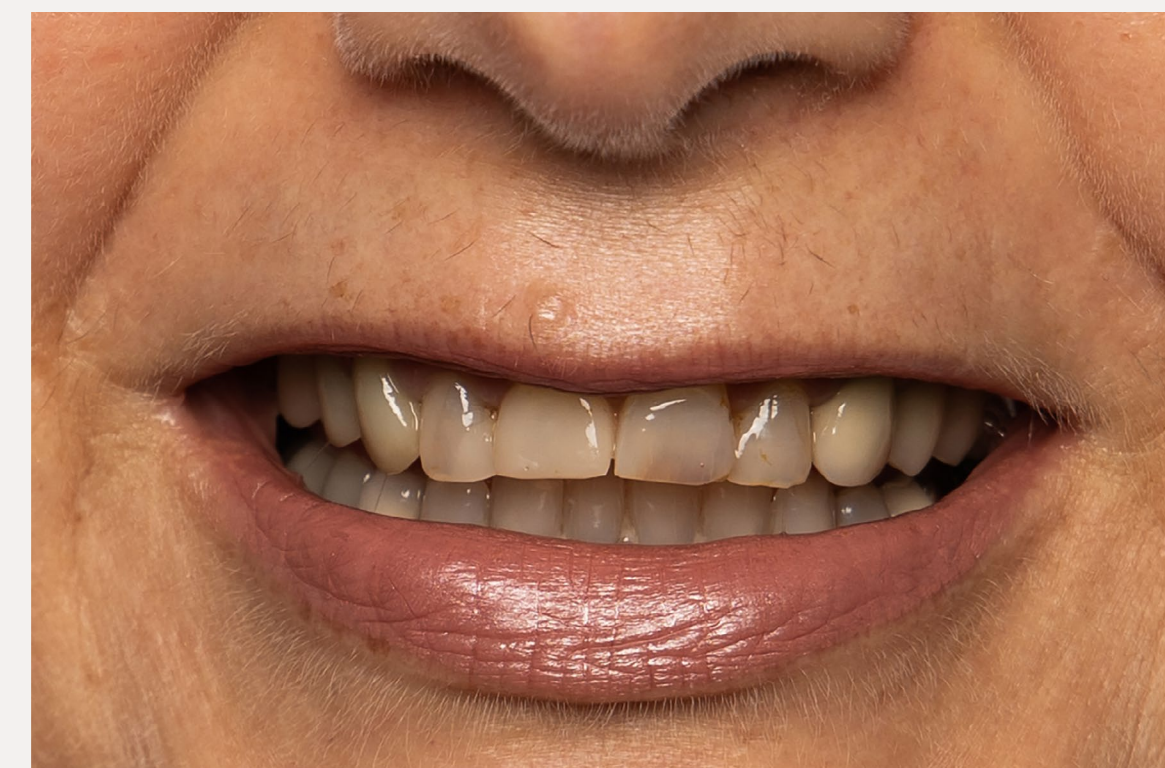
Before:
Inadequate fillings on teeth 12-22, an uneven gingival line on 12-11, and incisal edges severely eroded.

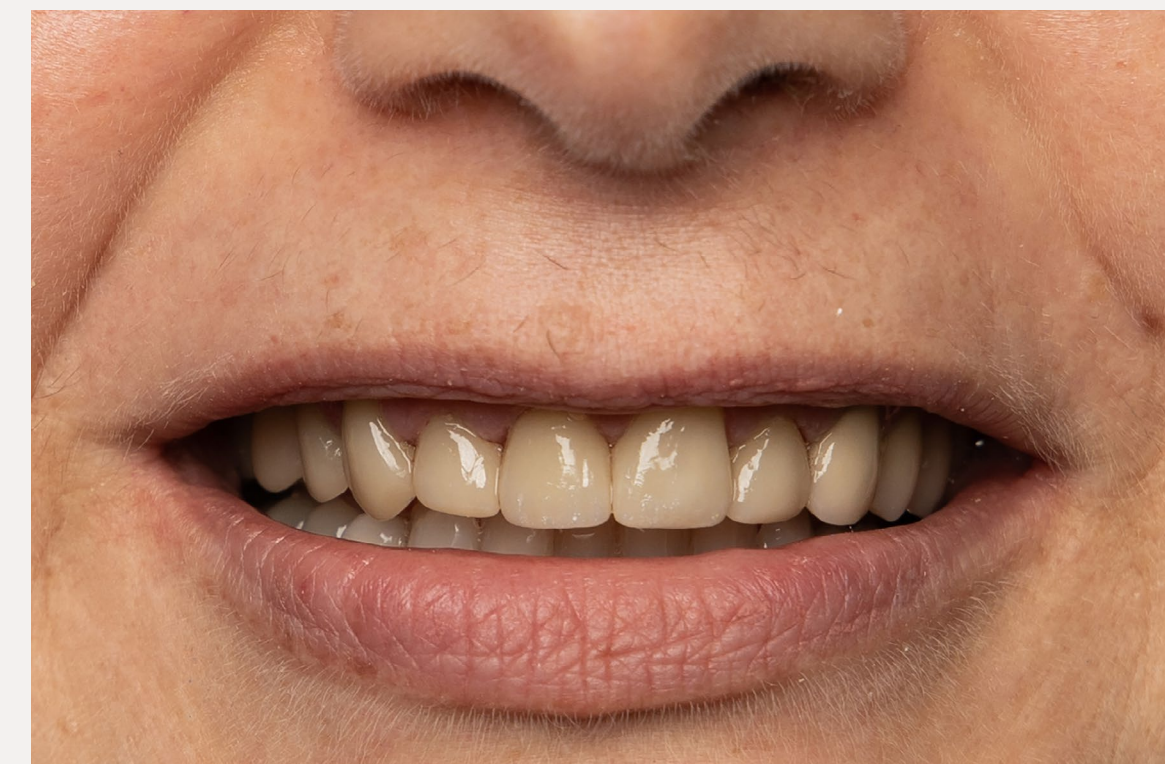
After:
Four highly esthetic and individualized lithium disilicate ceramic crowns.

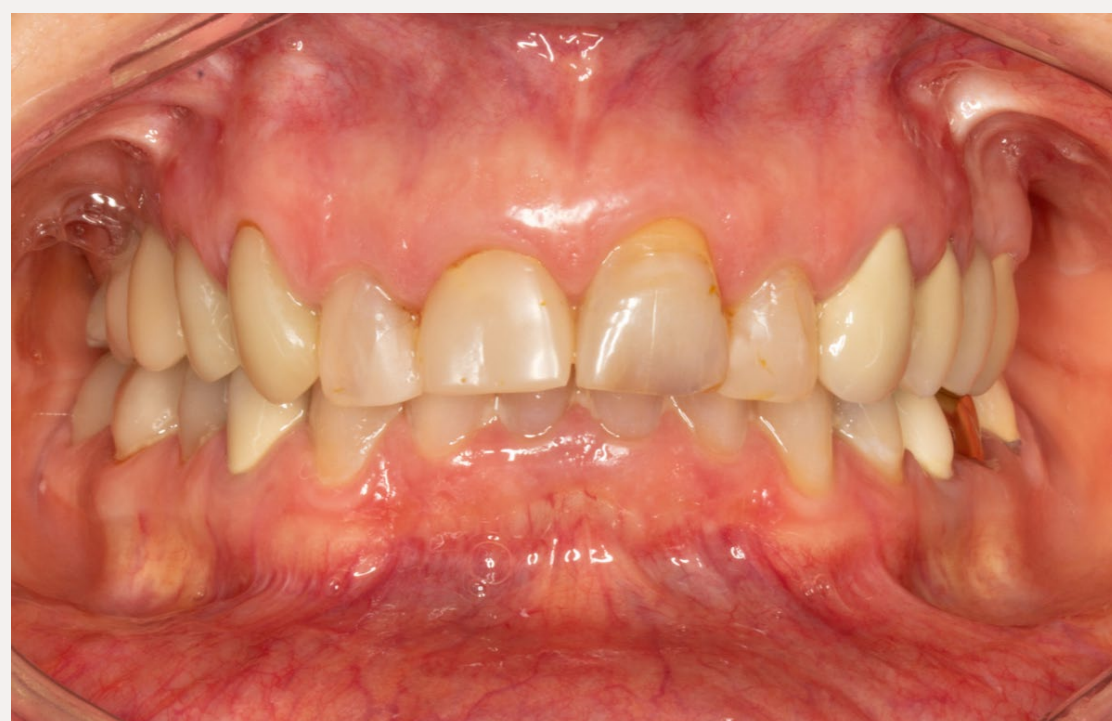
Insufficient fillings in the upper front and abraded incisal edges. Crowns 23-26 were made elsewhere several years ago and should be replaced with the next procedure.

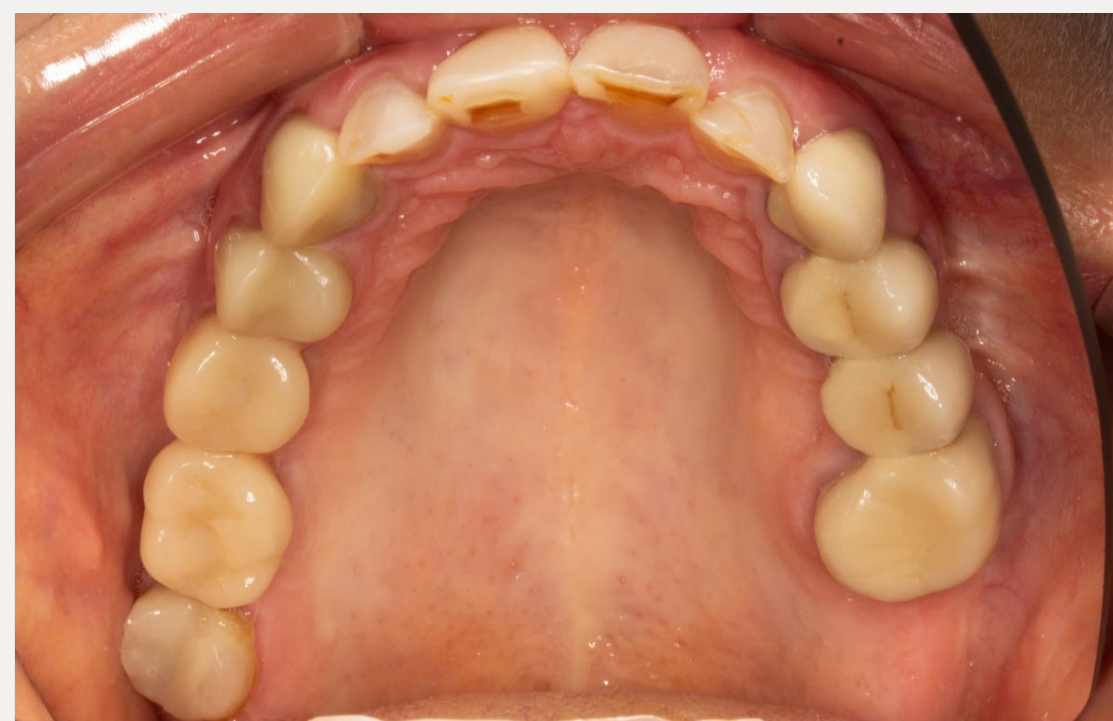
Also from palatal the teeth 12-22 had a severe destruction.

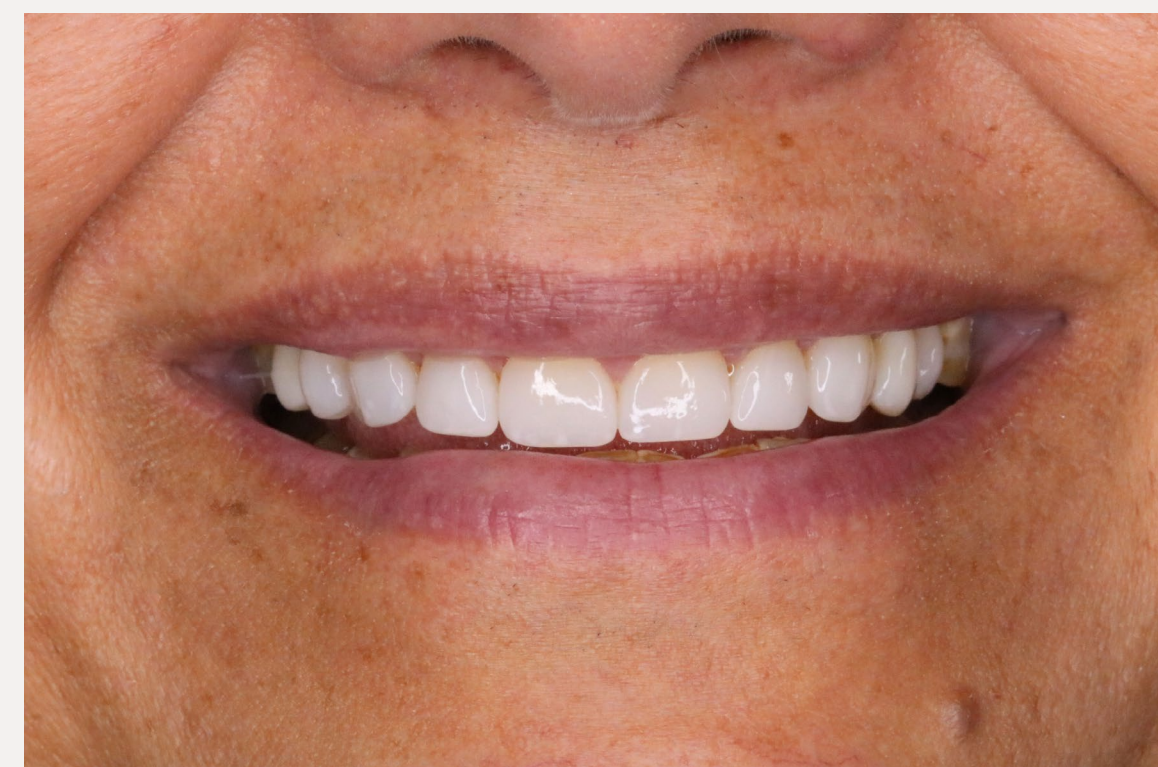
After:
Ten highly esthetic single crowns individualized with stains.

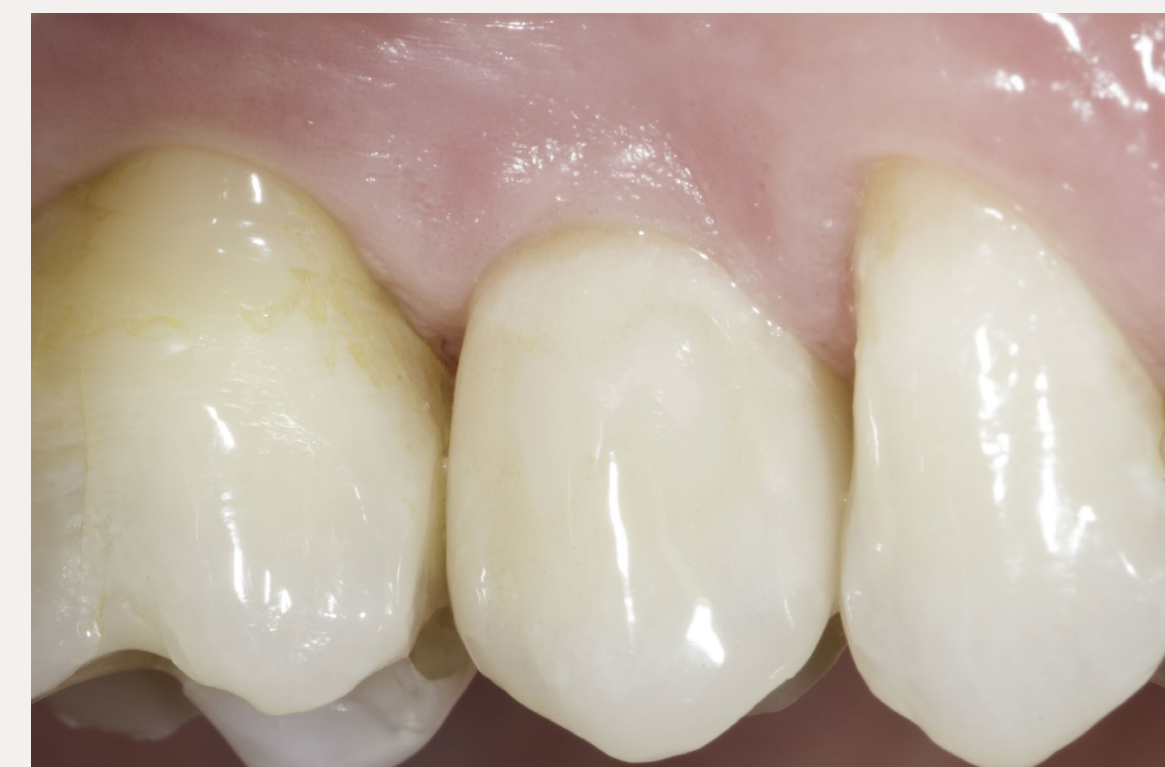
Tooth 15 was extracted four months before due to a longitudinal fracture. Patient wanted to close the resulting tooth gap.

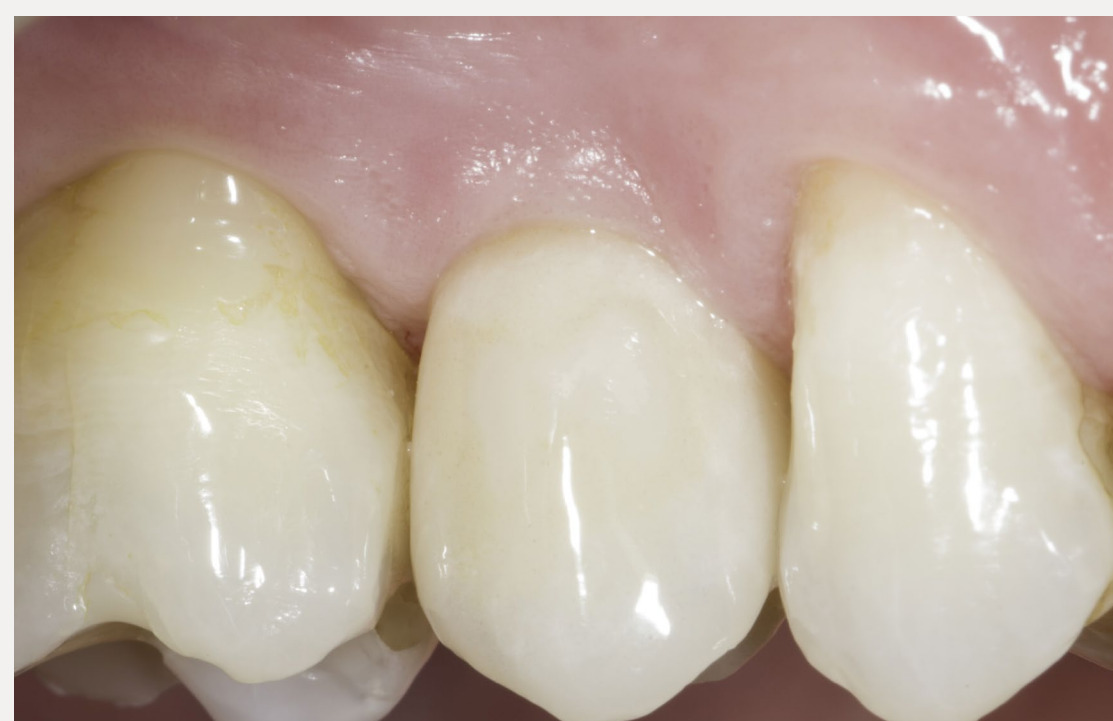
Healthy gingiva conditions around the crown after a lying period of 6 months.

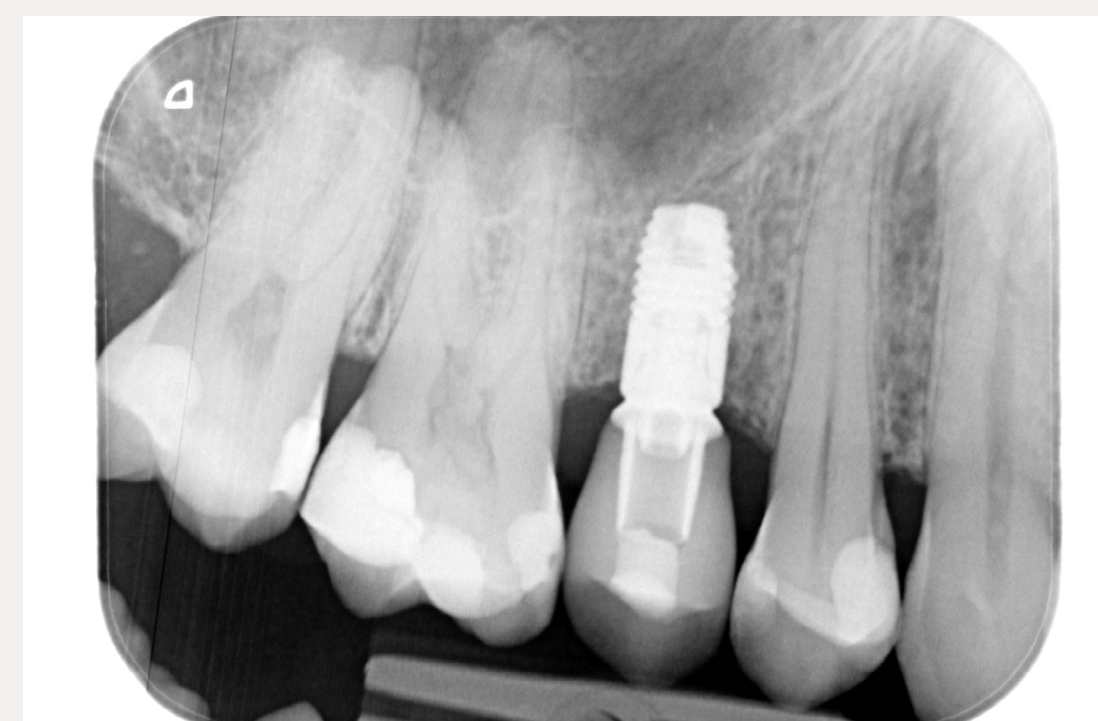
Healthy bone conditions around the implant after a lying period of 6 months.

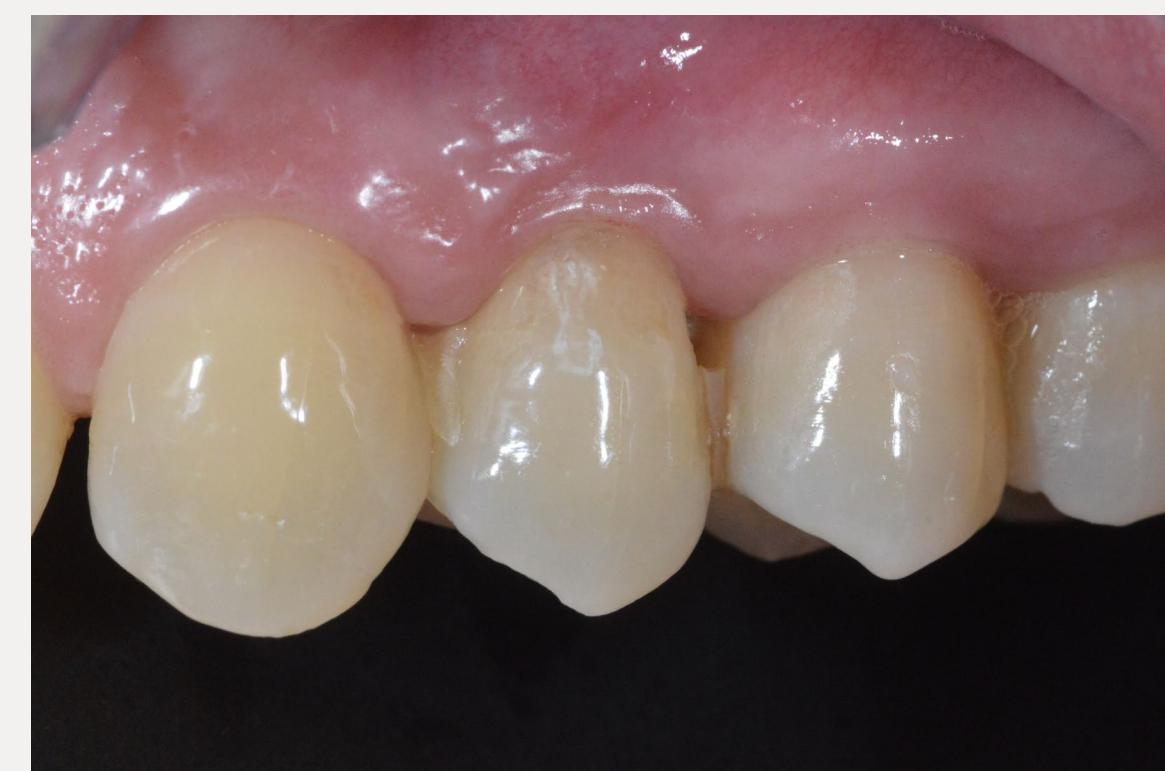
Before:
Initial situation.

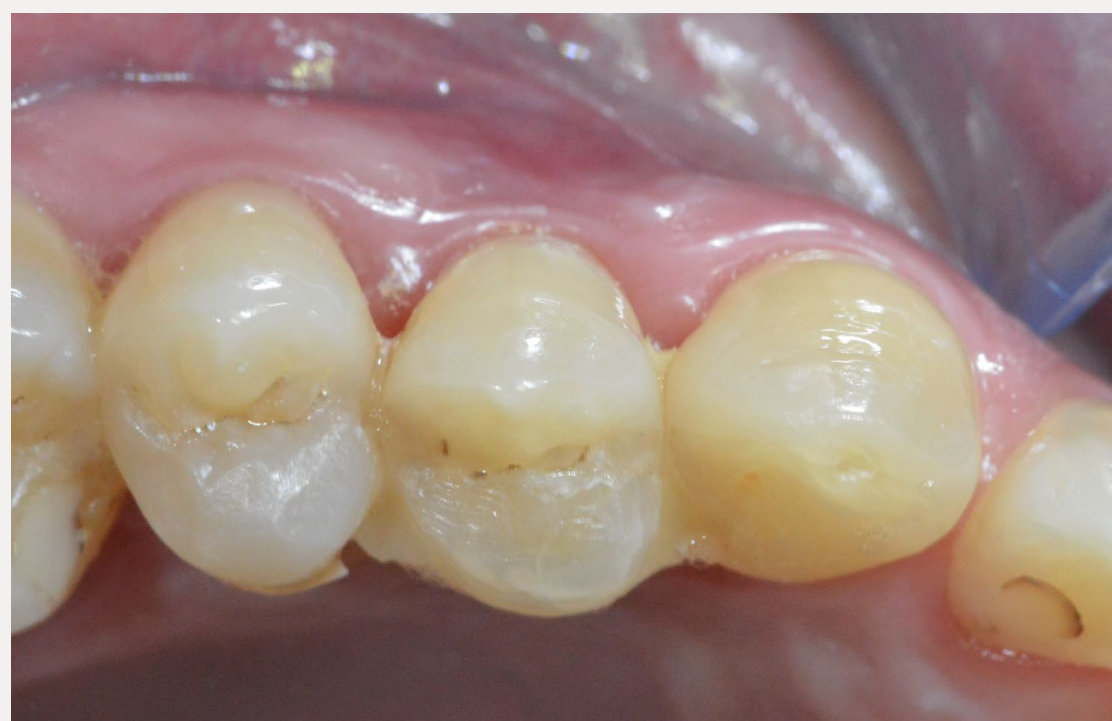
Horizontal root fracture and a periapical infection caused patient pain and some loosening of tooth 24.

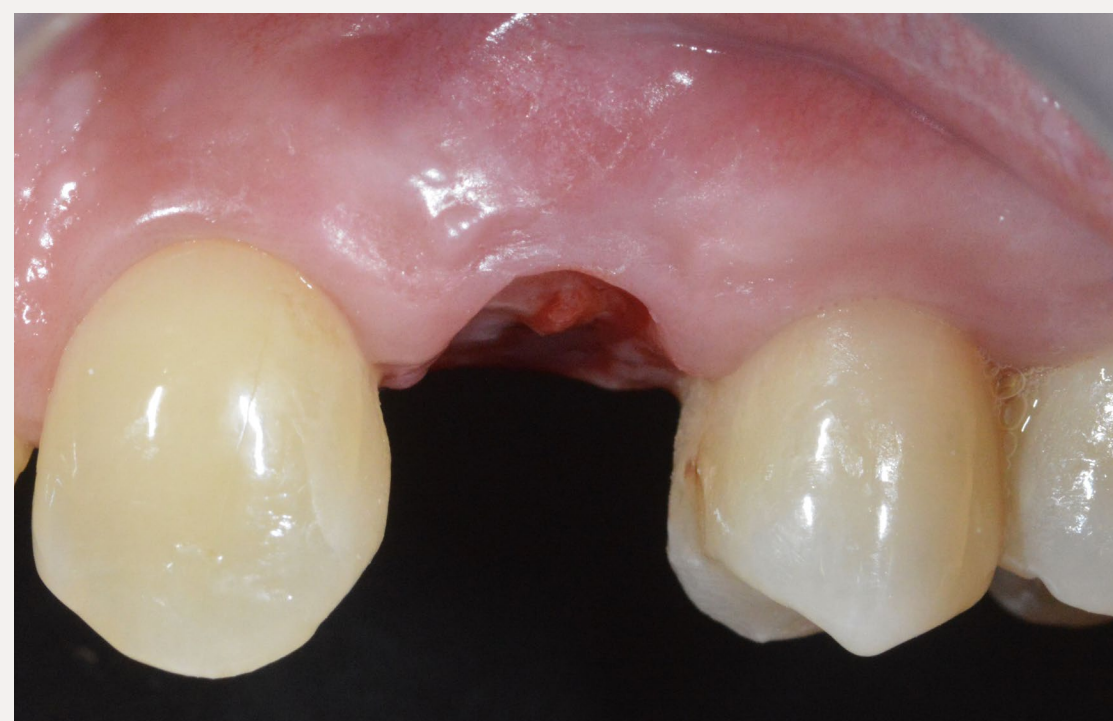
Extraction of fractured tooth

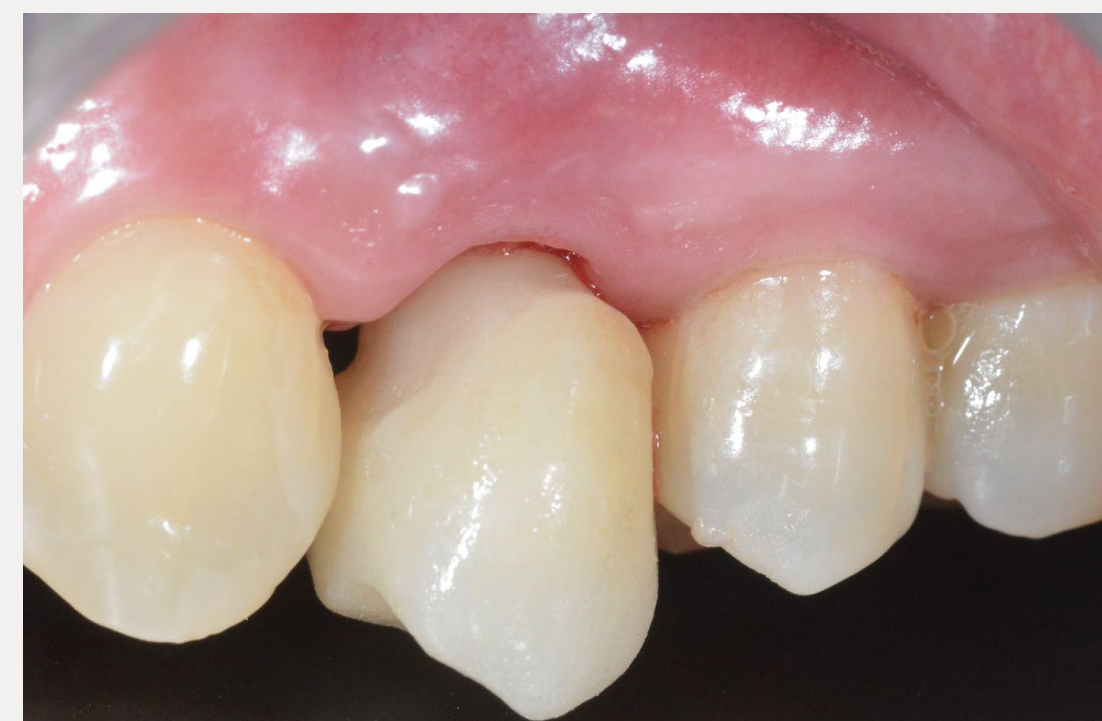
Three months later: final prosthetic restoration

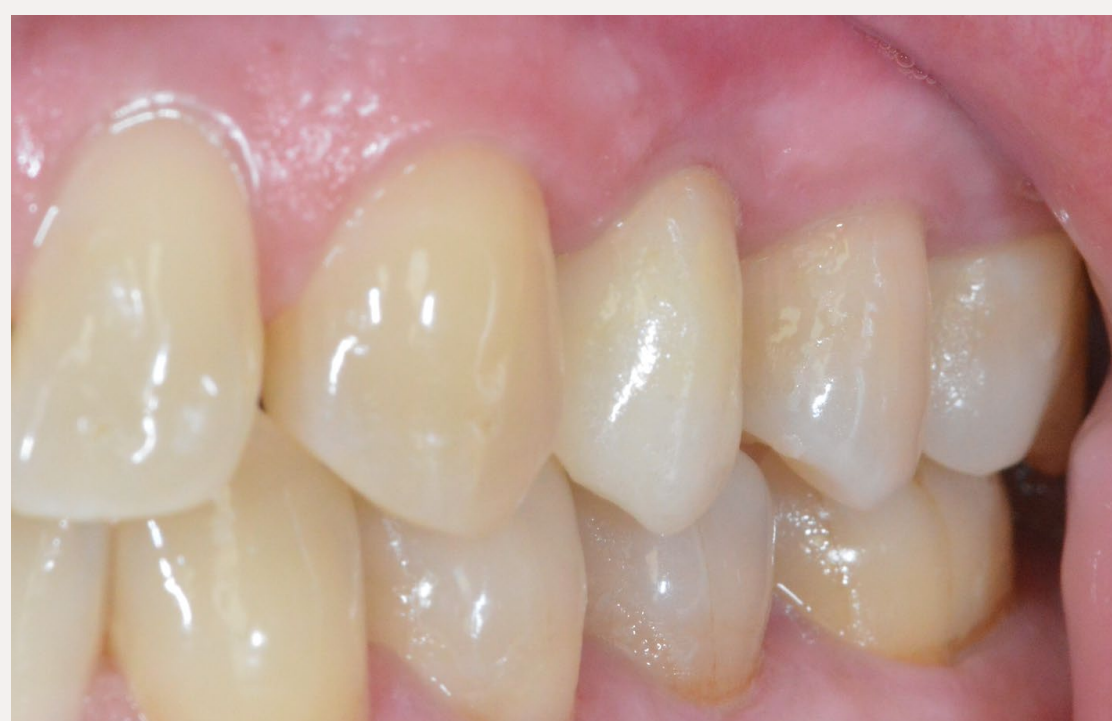
Result: preservation of esthetics and the natural soft tissue contour.
