Two CEREC Tessera crowns and two inlays – Quadrant rehabilitation

Case Description

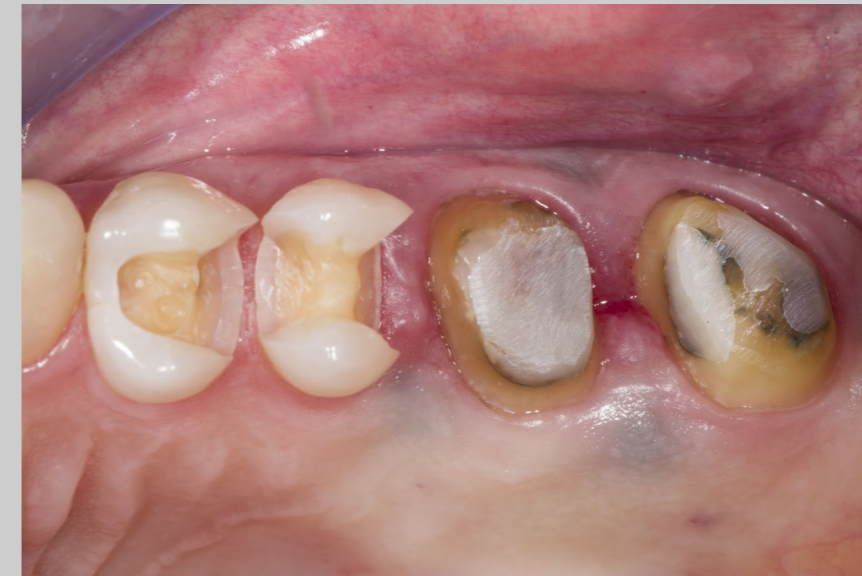
Before:

Insufficient fillings in the second quadrant. The restorations were about 15 years old.

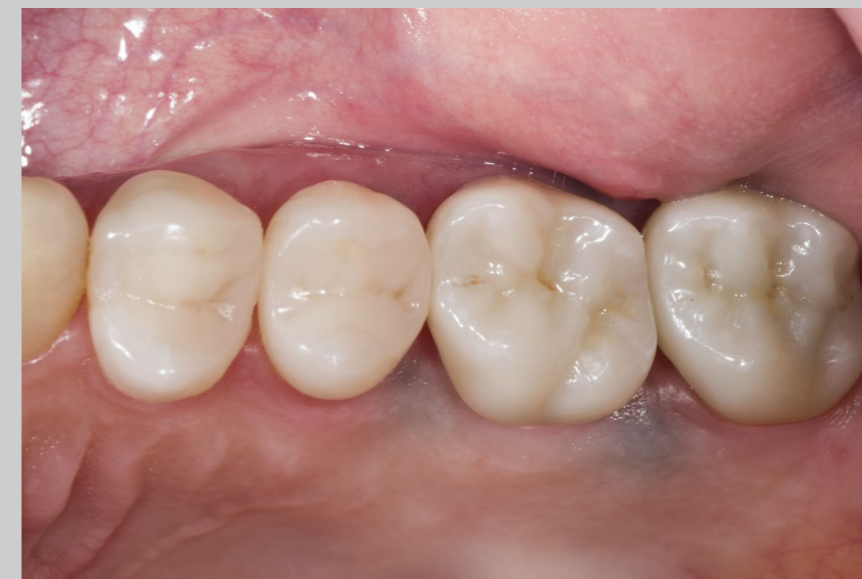
After:

Chairside-fabricated crowns made from CEREC Tessera (teeth 26/27). Inlays for teeth 24 and 25 with Tetric CAD, Ivoclar Vivadent.

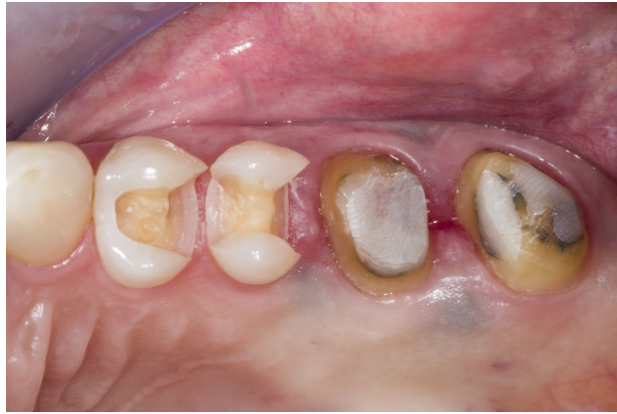
Patient with insufficient fillings in the second quadrant and inadequate esthetics of the PFM crowns on teeth 26 and 27. The composite filling on tooth 25 showed an open discolored joint with incipient secondary caries, and a distinct step was palpable toward the cervix of tooth 24 on the filling.

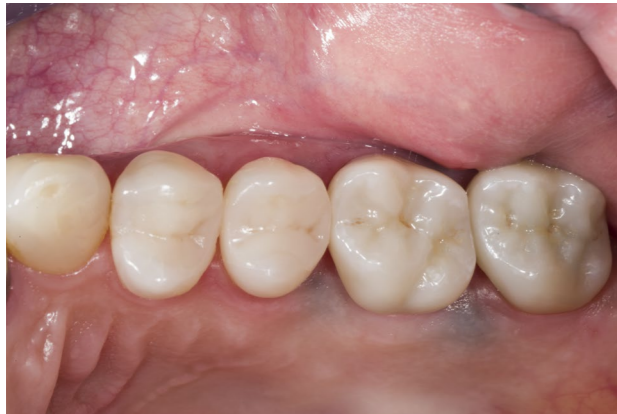
Final crown and inlays - occlusal.

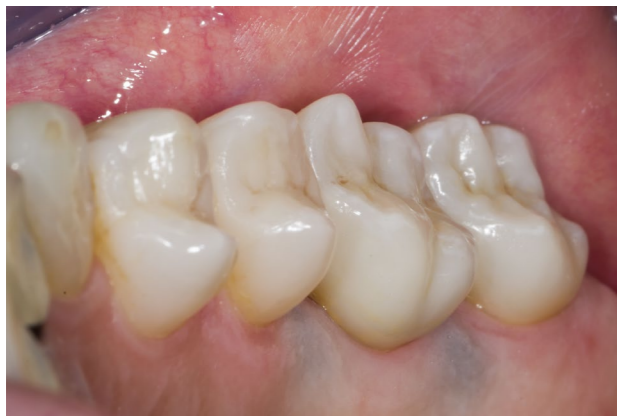
Final crown and inlays - palatal.

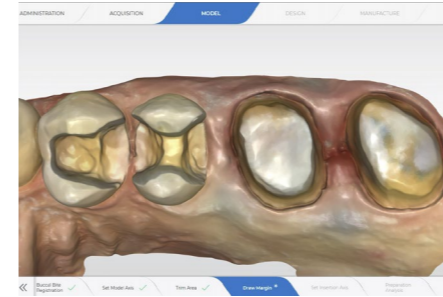
Intraoral scan of the insufficient fillings, using CEREC Primescan.

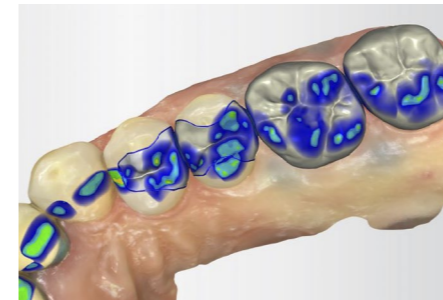
A slight modification of the design proposal was needed to adjust the occlusal contacts.

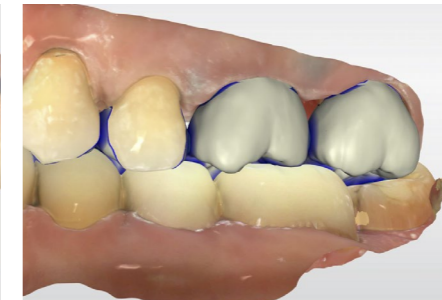
Buccal preview of crowns in CEREC Software.

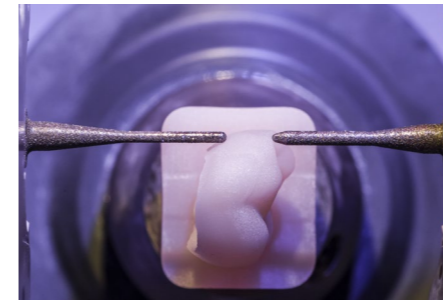
Crown being milled in CEREC Primemill.

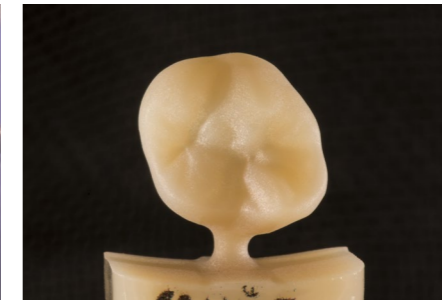
Final crown without final preparation.
